# ROCKY BRANCH WATERSHED ASSESSMENT

MAY 20, 2016

CITY OF COLUMBIA  
UTILITY AND ENGINEERING DEPARTMENT  
1136 WASHINGTON STREET, 7TH FLOOR  
COLUMBIA, SOUTH CAROLINA 29201

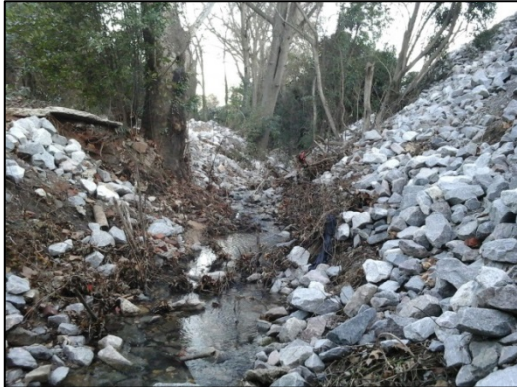
The northern most section of open stream channel lies between two parking lots southeast the intersection of Harden and Hampton Street. The stream emerges from an outfall, flows for 25 feet and then is piped underneath the southern parking lot. A 110-foot long dry swale converges from the east with the channel. There is some herbaceous vegetation in the channel and a large amount of residential trash has accumulated around the northern outfall.

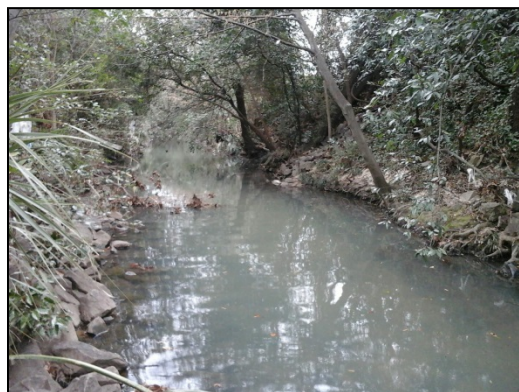
The upstream limit of open stream channel in the USC subwatershed is the Rocky Branch Mainstem within Maxcy Gregg Park. Stream banks are steep yet stable, with a thick layer of small trees and shrubs. Past riprap stabilization can be seen scattered along banks and in the stream bed. The channel substrate is primarily boulder and cobble material. The channel passes through a triple box culvert under Pickens Street and then continues downstream with similar channel conditions. This segment ends at the twin box culvert under Wheat Street.

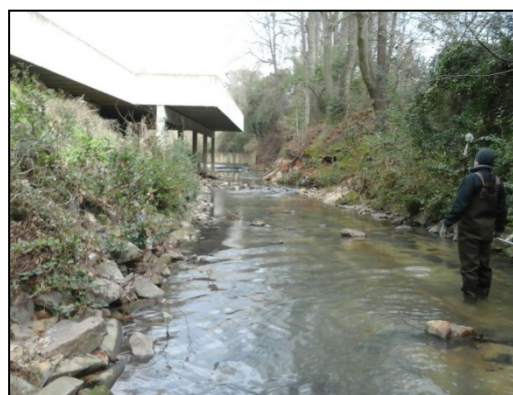
South (downstream) of Wheat Street, the entire stream channel has been straightened and converted to a flat bottom concrete bed and vertical concrete banks. The concrete channel ends 500 feet downstream of Wheat Street. The channel bed is downcut into a large scour pool at the downstream limit of the concrete channel and the left bank is also highly unstable in this location. The channel is highly confined through this reach with the Solomon Blatt Physical Education Center and athletic fields along the right bank and the railroad embankment along the steep left bank. A balcony from the Physical Education Center overhangs the stream channel with pier supports within the active bed. The channel substrate is mostly coarse, with some fine deposition in the pools and some coarse mid-channel bars. The stream takes an abrupt turn at Sumter Street, through a road culvert identified as being in severe condition. This area acts as a pinch point and is modeled to produce a backwater condition at a 2-year storm event. The mainstem channel downstream of Sumter Street has concrete bed and banks that extend to the subwatershed boundary.

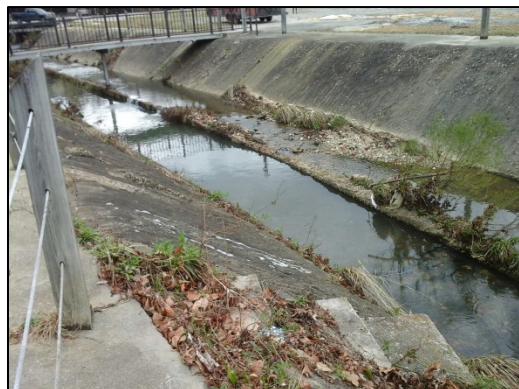
The mainstem channel in the MV-A subwatershed begins just downstream of the Sumter Street crossing. The bed and banks are contained within a concrete trapezoidal channel with approximately 7-foot tall banks. The stream is open for a short segment before being covered by a 160-foot long bridge adjacent to the USC College of Engineering and Information Technology building. The stream emerges as open channel for 270 feet before passing under Catawba Street. The culvert at Catawba Street and the concrete crossing adjacent to the Engineering building were

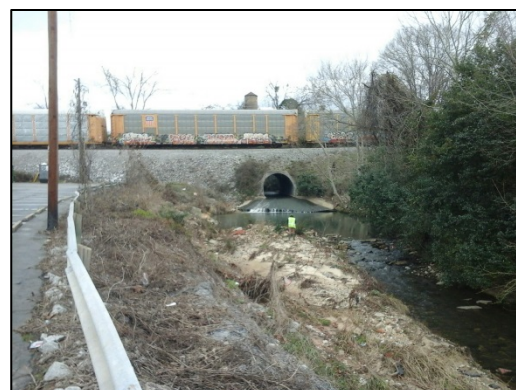
The downstream end of the culvert under Whaley Street opens up into a scour pool with large deposits of sand and gravel. A brick wall with multiple pipe outfalls stabilizes the left bank at the corner of Whaley and Main Street. The bed is mostly sand with cobble and gravel along the riffles. The stream passes through a large CMP culvert underneath a railroad crossing that show signs of bed incision and headwall cracking upstream. The skewed angle of entry and volume of flow at this junction likely contributes to reported flooding upstream. There is a steep concrete apron downstream of the culvert outfall and a deep scour pool immediately downstream of the apron. The concrete apron and scour pool may hinder fish passage due to the relatively large difference in elevation between the apron and the downstream channel and the shallow fast flow along the apron. The right bank downstream is approximately 12-feet tall and eroded, with pockets of gabion basket and riprap stabilization. The left bank is low and vegetated. The channel substrate is primarily sand, with some boulder, cobble, gravel and exposed bedrock along riffles. The downstream limit of this segment is at a double box culvert that conveys the stream under Assembly Street.

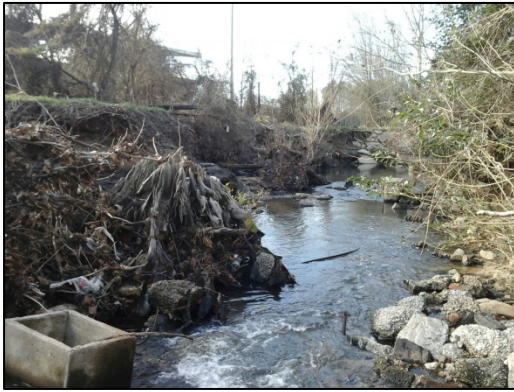
A tributary converges with the mainstem upstream of the railroad culvert. The channel is narrow and deeply incised, with approximately 10- to 12-foot tall banks. The channel is eroding parts of the railroad embankment along the left bank, causing slumping of embankment material.

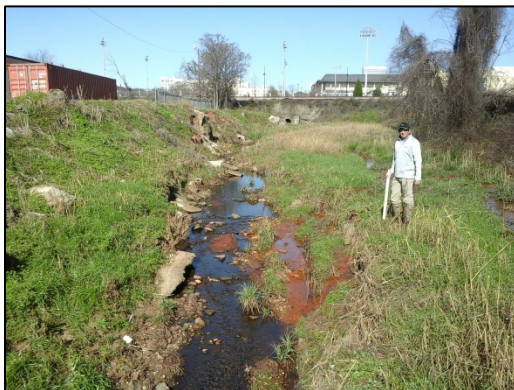
The last mainstem segment passes through a forested parcel located west of the City baseball stadium and downstream of the culvert at Dreyfuss Road. Large broken concrete slabs are present throughout the channel, which may indicate past channelization or attempts to stabilize the banks. Despite the unnatural appearance of concrete rubble, stream banks are stable. The concrete slabs in the channel create small cascades that could potentially block fish passage. The channel substrate is primarily sand, with some large boulder, exposed bedrock, cobble and gravel.

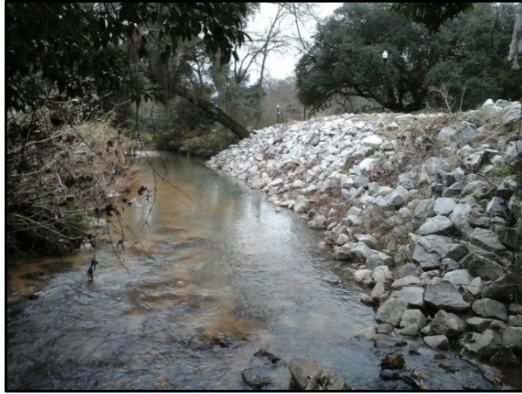
The UH subwatershed contains a small section of open channel along the mainstem of Rocky Branch and located entirely within Maxcy Gregg Park. The upstream limit is an old, degrading railroad trestle that crosses the stream at the subwatershed boundary. A sanitary line is exposed along the bed spanning 50 feet directly beneath the railroad trestle. Immediately downstream of the trestle, a stacked stone wall is along the right stream bank and riprap stabilizes the left. Several isolated sections of bank erosion occur along the right bank throughout Maxcy

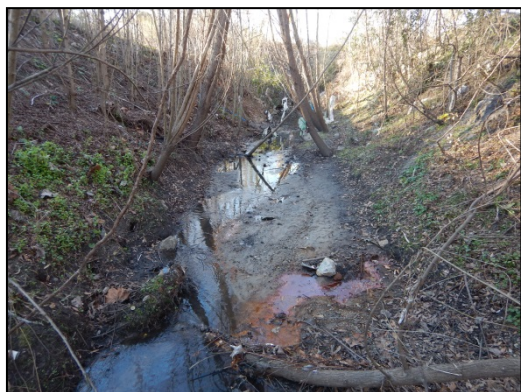
There are only two segments of open channel in the entire subwatershed. The first, and smaller of the two segments, is located in the northern portion of the subwatershed, east of the Hampton Street and North Millwood Avenue intersection. The channel segment begins at a gabion headwall at North Millwood Avenue and contains three individual stormwater outfalls. The banks are stabilized with thick vegetation primarily consisting of small trees and shrubs. The stream bed substrate consists primarily of sand and silt. Previous flooding levels are indicated

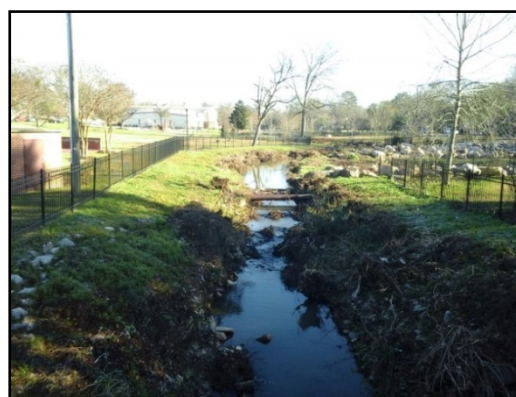
The second open channel segment in this subwatershed begins at the northeastern edge of MLK Park, where the stream emerges from underneath Heidt Street. The open channel section within MLK Park was recently restored using natural channel design and stabilization techniques. The entire stream corridor within the park is fenced in. Grade controls including large boulders across the bed and bank stabilization are present throughout this segment. Isolated areas of erosion are located along the outsides of bends, resulting in sediment sloughing off of the 6 to 7-foot banks and portions of the park fence falling down the eroding slopes. Adjacent to Heidt Street, an exposed 18-inch sanitary pipe was observed crossing the stream. A cross vane structure is located immediately downstream of this pipe crossing. Erosion was observed along the left bank caused by the channel flanking the structure. A beaver dam located downstream of the park pedestrian bridge has altered the restored channel by causing localized backwater conditions. Further downstream, another exposed sanitary pipe was observed, and is spanning above base flow. The stream then enters a culvert beneath Pavilion Avenue and is piped through the Five Points neighborhood, eventually emerging in the southern portion of the Gregg Street subwatershed.

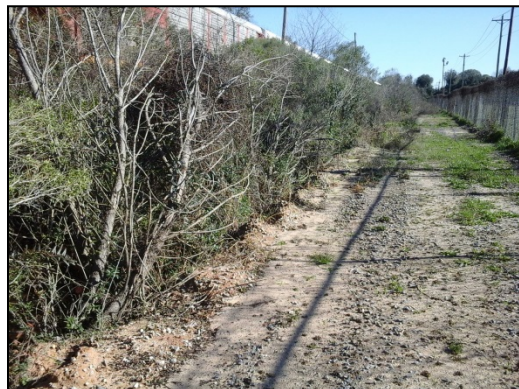
The channel network in the eastern portion of the RW subwatershed consists of two drainage swales adjacent to the railroad, one to the north of the railroad and one to the south. The channel on the southern side of the railroad is narrow and vegetated. The left bank is low and adjacent to a field used for overflow parking for the USC stadium. The right bank is limited by the railroad embankment. The channel on the northern side of the railroad is a wetland-like saturated system lacking defined banks for much of its length east of Rosewood Hills Drive. At the point where a second

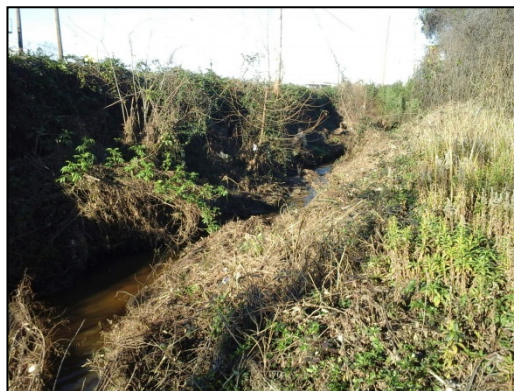
The culvert that traverses beneath the railroad north of the Assembly Street and Virginia Street intersection was considered to be in severe condition. The culvert is showing signs of significant degradation with active scouring around and behind the right pipe and heavy debris blocks the left pipe. The pipes have separated at terminal section joints. Soil slumping around these pipes is a severe threat to the railroad embankment that crosses this culvert.

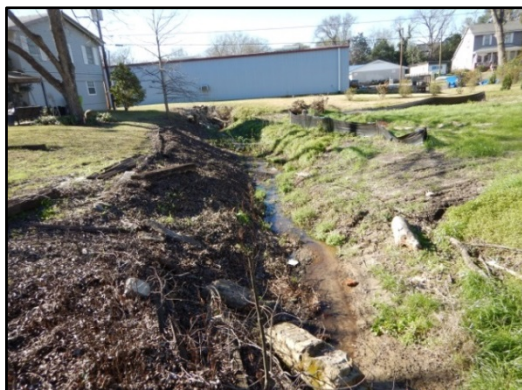
There is minimal open channel length in the FG subwatershed. There is one short section that flows underneath Ohio Street, between Whitney Street and Olympia Avenue. The stream is channelized, located between private properties, and has low, stable banks. The channel bed lacks feature diversity and the substrate includes mostly sand and silt.

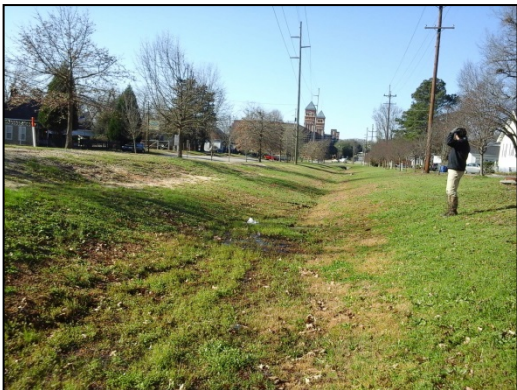
A small tributary converges with the mainstem on the right bank 130 feet upstream of Olympia Avenue. The tributary begins at a stormwater pond at the northeast corner of Heyward and Lincoln Street and continues downstream through a mowed grass swale in the median of Heyward Street. Within the median, the channel banks are low and stable and the channel bed is mostly sand. The channel is then piped into the mainstem at Olympia Park, with a small 80-foot open channel segment adjacent to the Olympia Park playground.
