# ROCKY BRANCH WATERSHED ASSESSMENT

MAY 20, 2016

CITY OF COLUMBIA  
UTILITY AND ENGINEERING DEPARTMENT  
1136 WASHINGTON STREET, 7TH FLOOR  
COLUMBIA, SOUTH CAROLINA 29201

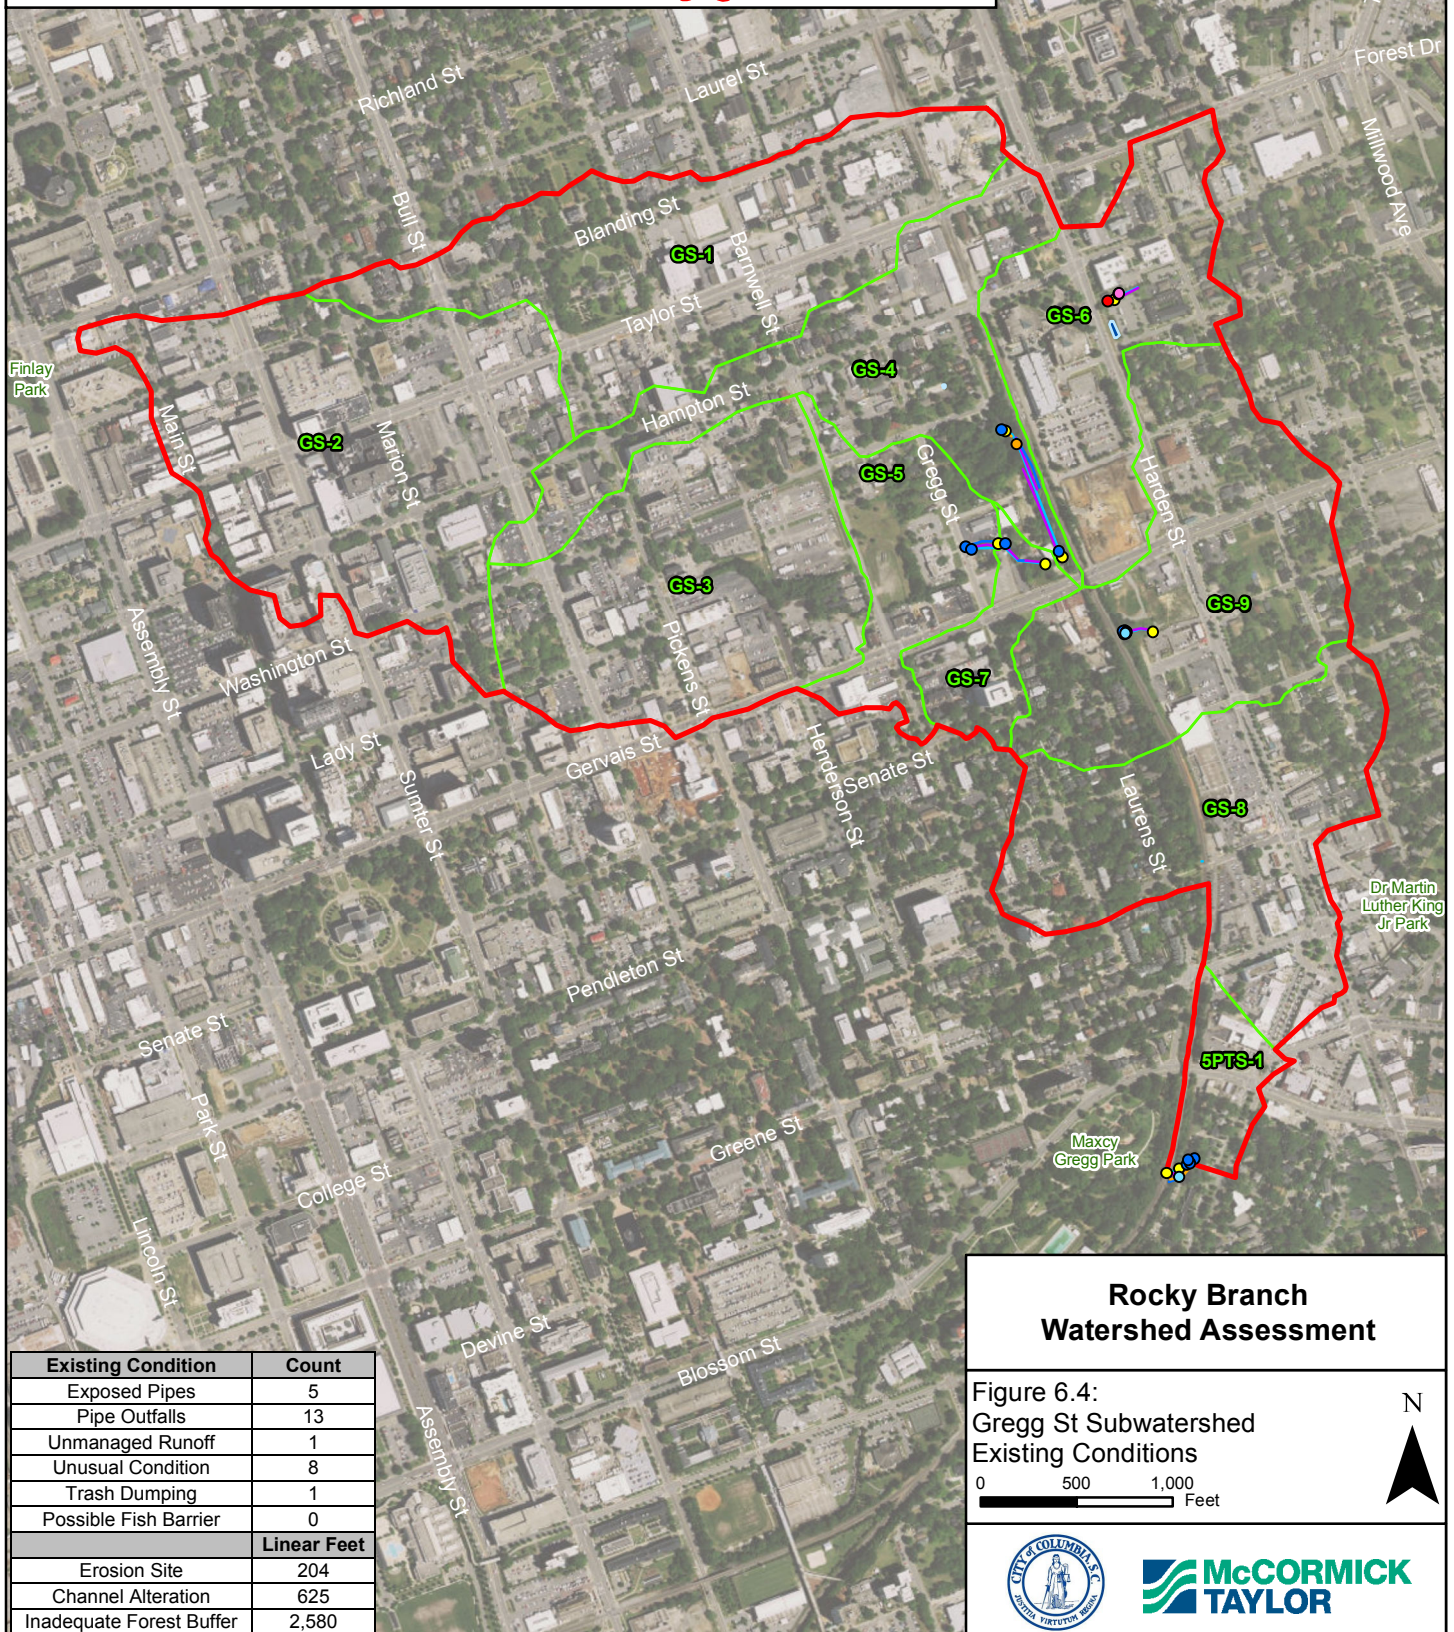
The northern most section of open stream channel lies between two parking lots southeast the intersection of Harden and Hampton Street. The stream emerges from an outfall, flows for 25 feet and then is piped underneath the southern parking lot. A 110-foot long dry swale converges from the east with the channel. There is some herbaceous vegetation in the channel and a large amount of residential trash has accumulated around the northern outfall.

To the southwest of the stream previously described is an open channel stream segment that emerges from an arched brick outfall at Gregg Street. Both of the 3 to 4-foot tall banks are stabilized with riprap at the upstream limit. The bed substrate is primarily sand and gravel with point bars present in the bends. The channel flows through a box culvert at a commercial driveway and is open again for a short segment before entering a concrete pipe conveying flow underneath Gervais Street.

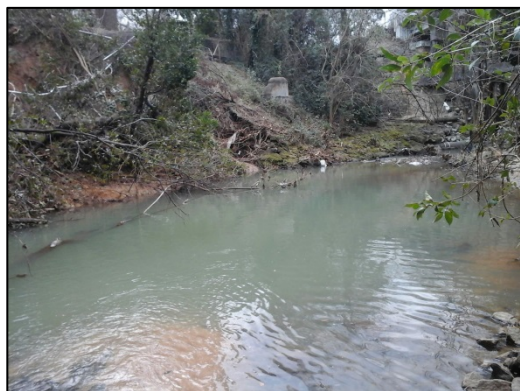
Another small segment of open stream channel is located south of the intersection of Gervais and Laurens Street. This stream segment receives all flow from previously described open channel. The stream originates from a stone block masonry arch emerging from underneath the railroad. Two 36-inch reinforced concrete pipes enter the channel from the left bank. A significant headcut has formed behind the pipes as a result of overland flow and concentrated runoff from Laurens Street and a parking lot adjacent to the stream. Two sanitary lines are exposed in the stream bed and one sanitary line runs along the right bank from a manhole stack into the railroad culvert. The 3 to 4-foot tall banks are vegetated with herbaceous cover and are stable. The channel substrate consists primarily of cobble, with some concrete and rubble from the banks slumped into the bed. The stream then flows into twin concrete pipes flanked by stone walls on either side.

- South of Gervais, at the railroad west of Harden Street, stabilize the embankment behind the headwall at the railroad and stabilize outfalls at the south end of Laurens Street

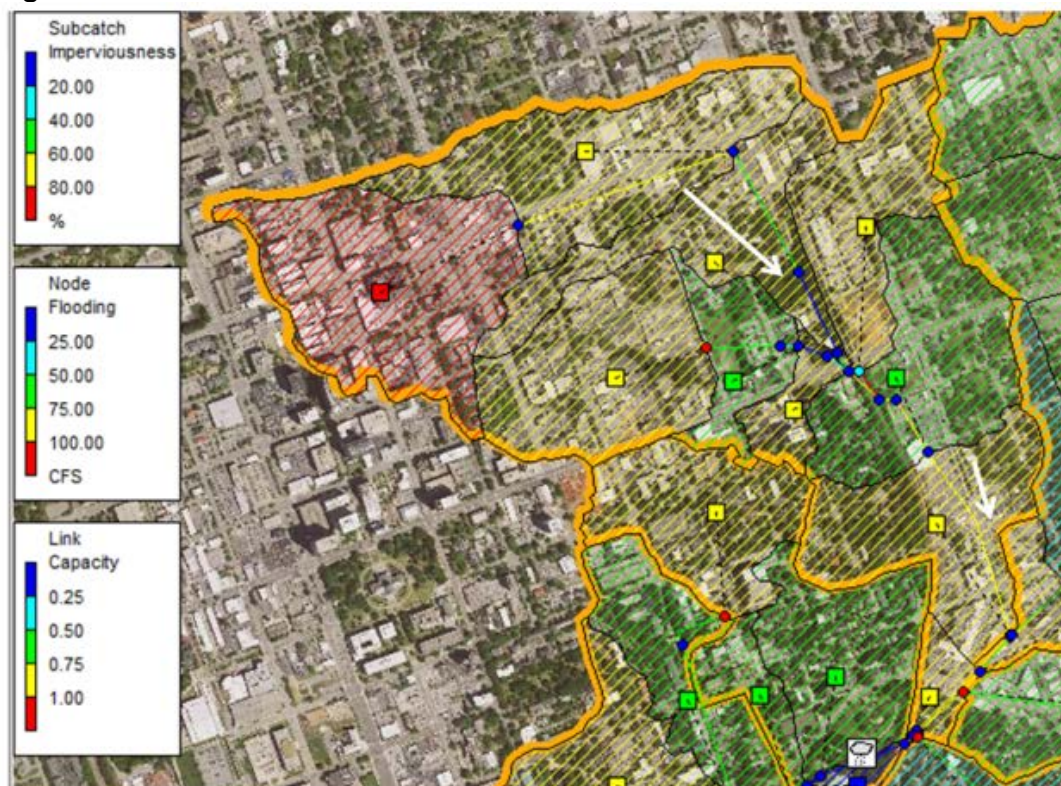
**Figure 6.5 GS SWMM Model**

The GS subwatershed was modeled as 10 subcatchments in SWMM. These subcatchments all ultimately drain to dual 72 inch RCPs, which connect underground to the culverts in the Five Points area. The flows from the GS subwatershed converging here cause frequent flash flooding in this area during moderate rain events. The SWMM Model shows this line is at almost 80% capacity during a 2-year event where it ties into these culverts, and indicates flooding is initiated in several areas of the subwatershed for this frequency of event.

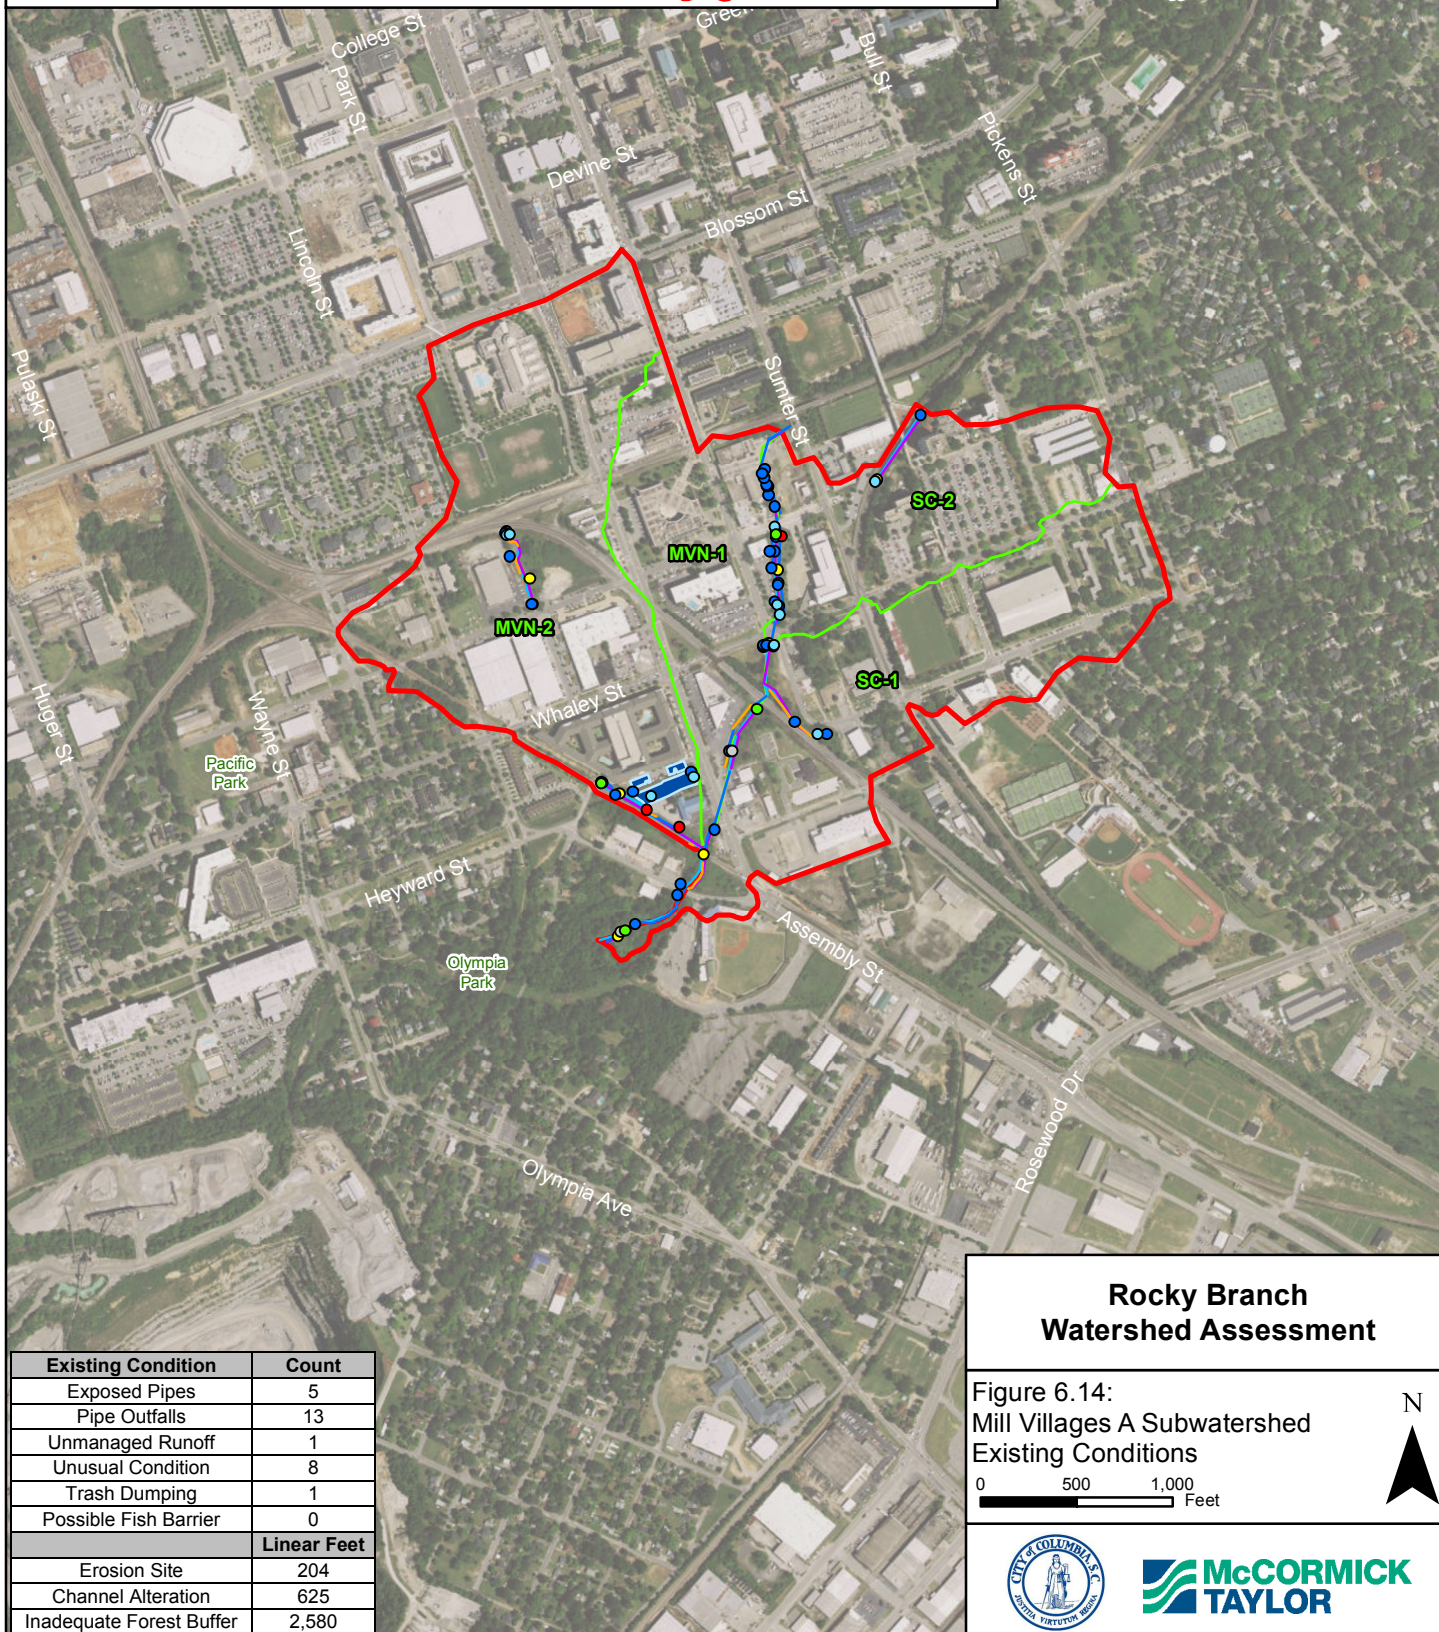
**Figure 6.14** highlights existing conditions that were either captured during the stream cruising effort or developed using GIS data.

both considered to be in severe condition due to the extent and condition of channel alteration and evidence of recent flooding. Downstream of Catawba Street, the concrete channel continues for 190 feet. Buckling and cracks were observed along the concrete bed downstream of Catawba. Downstream from the end of the concrete bed, the banks are stabilized with concrete for a short length along the right bank and timber retaining walls over the remainder of the bank surface. The channel then passes through a double box culvert under Whaley Street.

The downstream end of the culvert under Whaley Street opens up into a scour pool with large deposits of sand and gravel. A brick wall with multiple pipe outfalls stabilizes the left bank at the corner of Whaley and Main Street. The bed is mostly sand with cobble and gravel along the riffles. The stream passes through a large CMP culvert underneath a railroad crossing that show signs of bed incision and headwall cracking upstream. The skewed angle of entry and volume of flow at this junction likely contributes to reported flooding upstream. There is a steep concrete apron downstream of the culvert outfall and a deep scour pool immediately downstream of the apron. The concrete apron and scour pool may hinder fish passage due to the relatively large difference in elevation between the apron and the downstream channel and the shallow fast flow along the apron. The right bank downstream is approximately 12-feet tall and eroded, with pockets of gabion basket and riprap stabilization. The left bank is low and vegetated. The channel substrate is primarily sand, with some boulder, cobble, gravel and exposed bedrock along riffles. The downstream limit of this segment is at a double box culvert that conveys the stream under Assembly Street.

Downstream of the road culvert at Assembly Street, the channel appears to have been historically straightened, with broken concrete, riprap, and gabion baskets stabilizing the 15-foot tall banks. The bed substrate consists primarily of sand, riprap and concrete. The stream passes under a railroad trestle and the substrate shifts to a higher concentration of boulder and cobble. Higher concentrations of trash were observed in this section, including a dumpster lodged underneath the railroad trestle. Bank heights are similar to the upstream region, although the left bank is eroding

The last mainstem segment passes through a forested parcel located west of the City baseball stadium and downstream of the culvert at Dreyfuss Road. Large broken concrete slabs are present throughout the channel, which may indicate past channelization or attempts to stabilize the banks. Despite the unnatural appearance of concrete rubble, stream banks are stable. The concrete slabs in the channel create small cascades that could potentially block fish passage. The channel substrate is primarily sand, with some large boulder, exposed bedrock, cobble and gravel.

Stream habitat quality within the streams of the MV-A subwatershed is generally poor. The channel segment adjacent to the USC College of Engineering and Information Technology building has greatly diminished habitat quality as a result of the concrete bed and banks providing no vegetative cover or riparian buffer, little epifaunal substrate/available cover, and excessive channel alteration. Downstream of the concrete channel, habitat improves marginally, though is degraded by sedimentation, lack of epifaunal substrate/ available cover and channel alteration. Sedimentation and marginal epifaunal substrate/available cover continues downstream of Whaley Street and bank stability and vegetative cover decreases as the channel conveys through the railroad culvert. West of Assembly Street, bank instability and poor vegetative cover continues to be an issue. Bank stability improves downstream of Dreyfuss Road, but sedimentation increases. Habitat quality within the isolated segment north of Catawba Street is in poor condition, impacted by marginal epifaunal substrate/available cover, high channel alteration, bank instability and marginal vegetative cover.

Thirty-eight outfalls were identified within the MV-A subwatershed during the field assessment. Two of these outfalls rated severe and one was rated very severe. The outfall rated very severe and one outfall rated severe are located south of the railroad at the head of the channel north of the Catawba Street and Park Street intersection. The railroad embankment has scoured and slumped behind the headwall, the headwall is undermined and cracked. Erodible soils and heavy erosion above and around the pipe are endangering the railroad embankment from which the outfall emerges. The other outfall in severe condition is located in the channel segment south of Catawba street. The pipe is fully inundated at baseflow, with 75% of the opening blocked with deposition

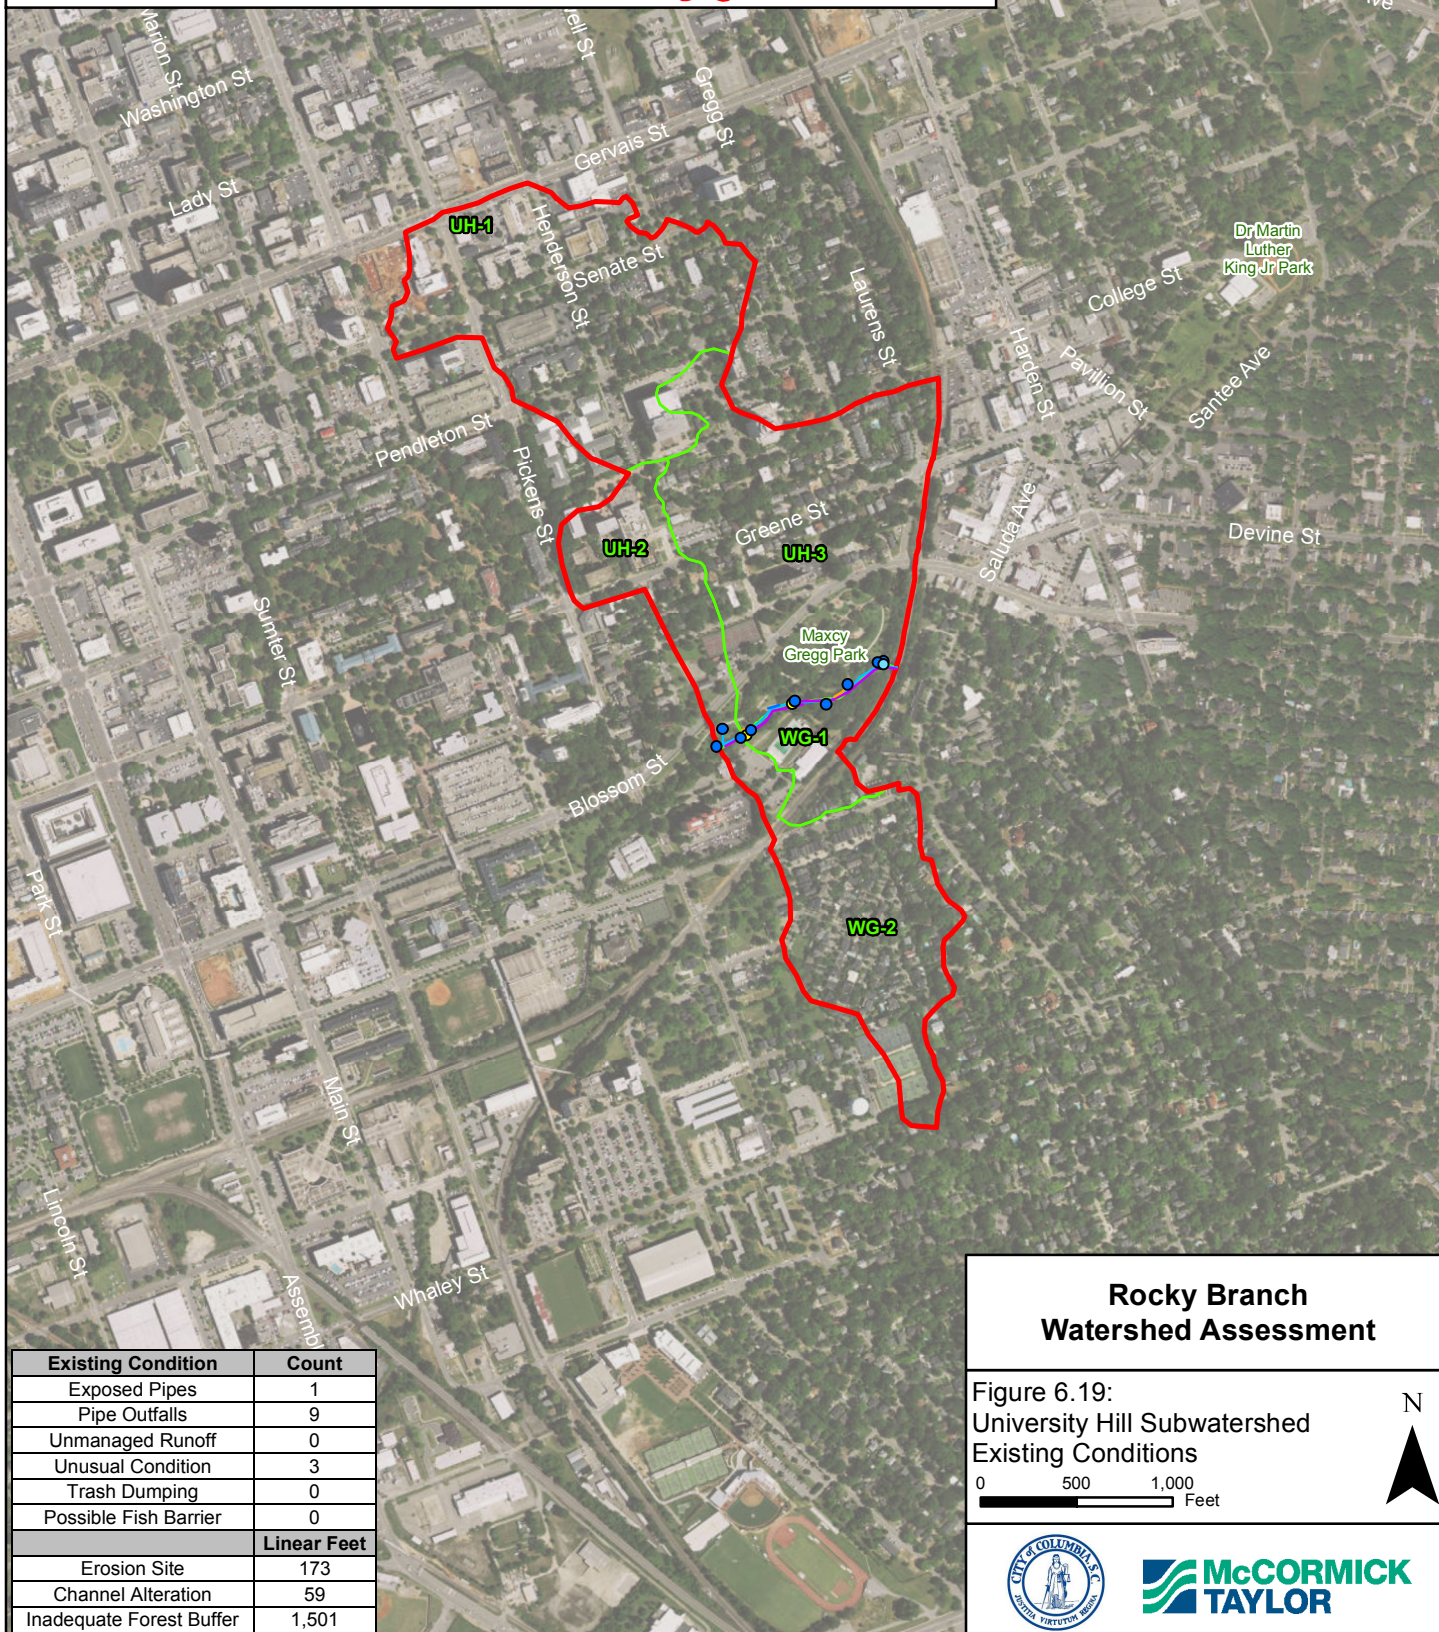
Figure 6.19:  
University Hill Subwatershed  
Existing Conditions

Existing Condition	Count
Exposed Pipes	1
Pipe Outfalls	9
Unmanaged Runoff	0
Unusual Condition	3
Trash Dumping	0
Possible Fish Barrier	0
	<b>Linear Feet</b>
Erosion Site	173
Channel Alteration	59
Inadequate Forest Buffer	1,501

The UH subwatershed contains a small section of open channel along the mainstem of Rocky Branch and located entirely within Maxcy Gregg Park. The upstream limit is an old, degrading railroad trestle that crosses the stream at the subwatershed boundary. A sanitary line is exposed along the bed spanning 50 feet directly beneath the railroad trestle. Immediately downstream of the trestle, a stacked stone wall is along the right stream bank and riprap stabilizes the left. Several isolated sections of bank erosion occur along the right bank throughout Maxcy

Stream habitat is in fair condition within the UH subwatershed. Sedimentation issues, a poor velocity/depth regime and a lack of epifaunal substrate/ available cover were the greatest impairments to the general habitat quality. At the upstream end near the railroad trestle, a very strong chemical odor and cloudy, green water color was observed. Approximately 70% of the stream banks had less than a 35-foot riparian buffer width. The upstream portion of the left bank had the most established vegetative growth. The remainder of the buffer had sporadic mature tree growth among mowed grass and low herbaceous vegetation.

All outfalls within the UH subwatershed were observed to be in minor to moderate condition.

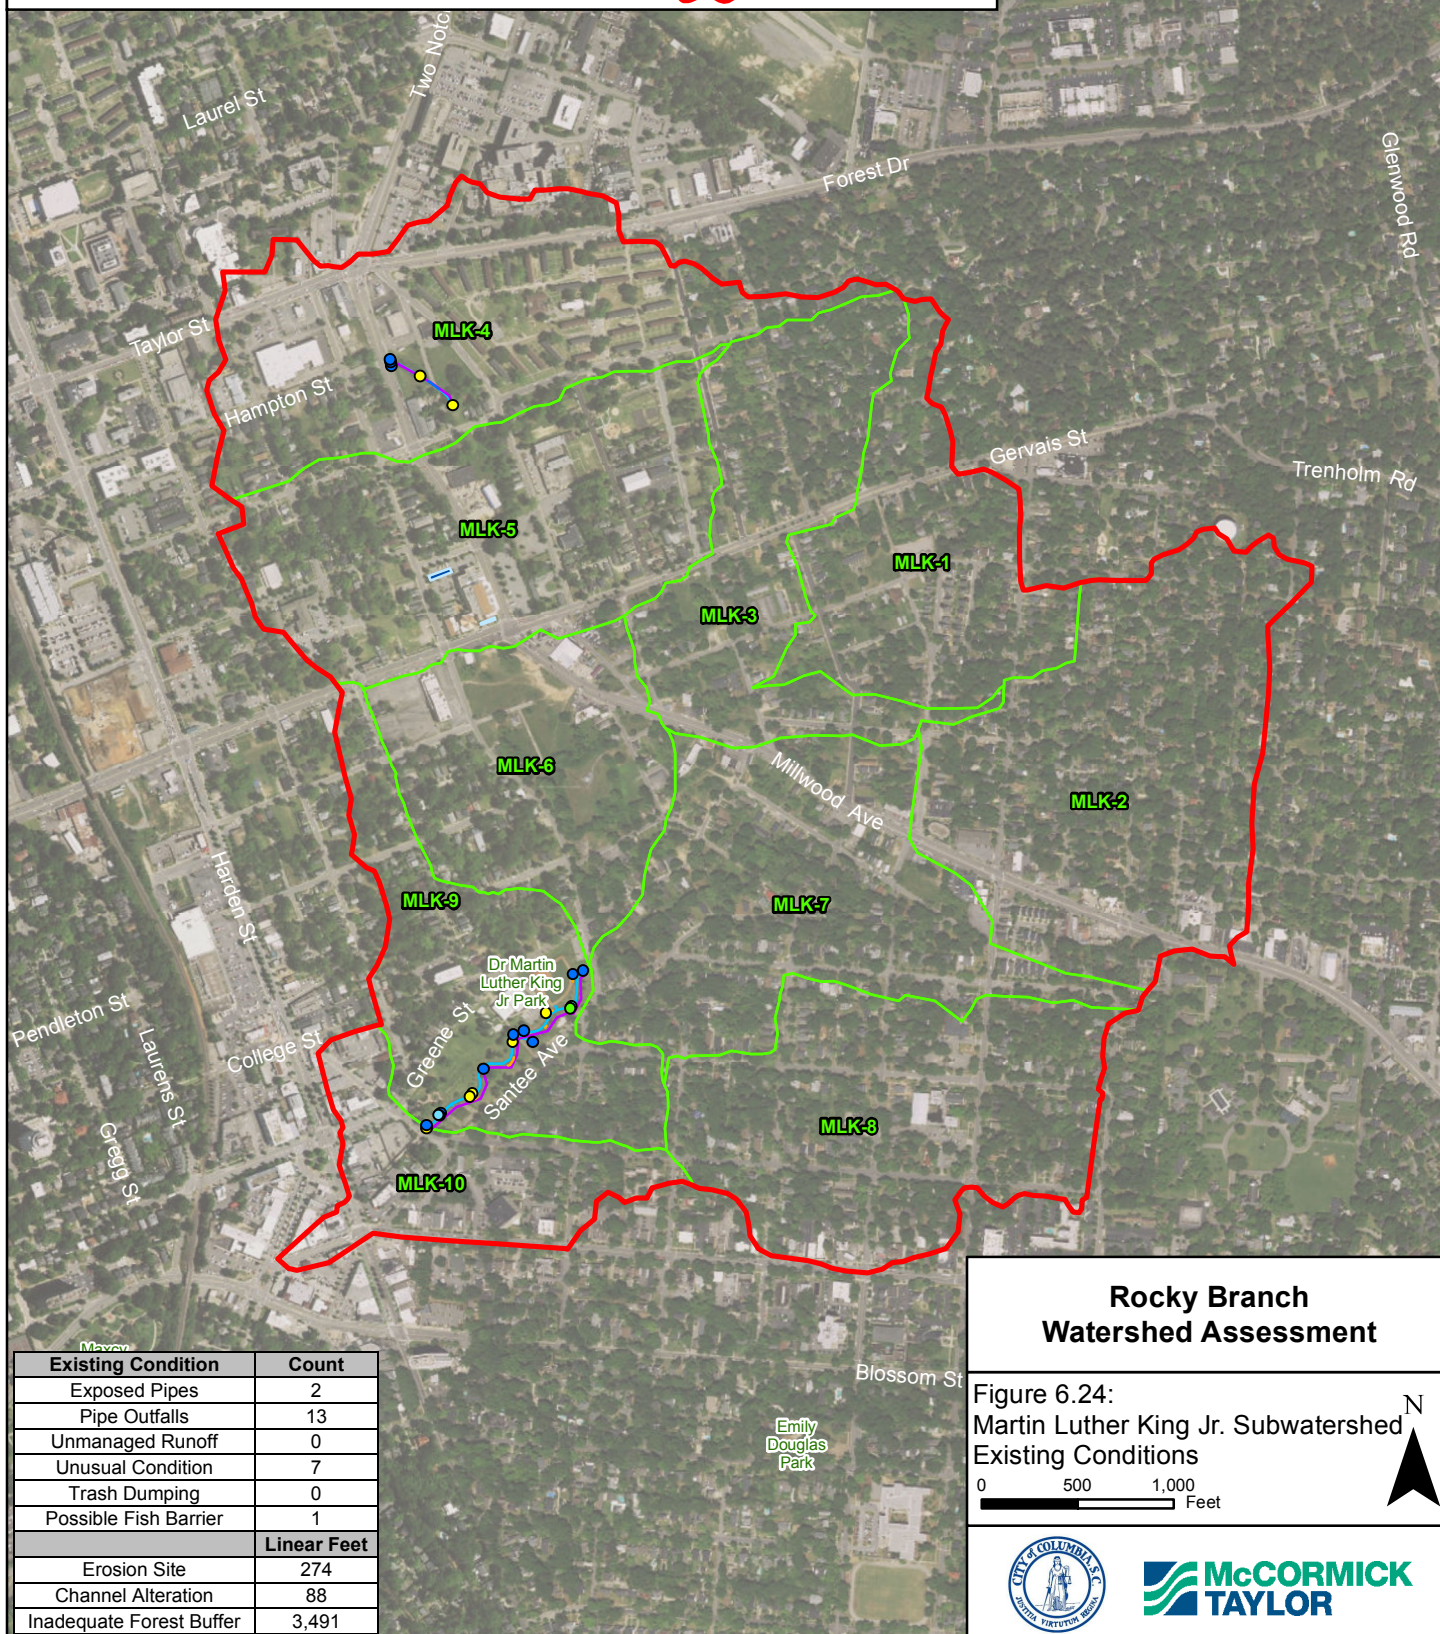
**Figure 6.24** highlights existing conditions that were either captured during stream cruising efforts or developed using GIS data.

Stream habitat quality is generally poor along both of the open channel segments in the MLK subwatershed. Common impairments observed included lack of riparian buffer, sedimentation issues and poor epifaunal substrate/available cover. The segment in the northern part of the subwatershed also had poor channel flow status (baseflow condition) and inadequate velocity/depth regime representation. Petroleum (fuel-like) odors were observed within this

segment. The reach within MLK Park had higher proportions of unstable/eroding banks compared to other reaches within the MLK subwatershed, but was generally in slightly better ecological condition.

The entire stream network within the MLK subwatershed has riparian buffer narrower than 35 feet. While some vegetation was observed along the stream banks of both segments, the riparian buffer region consists primarily of mowed grass.

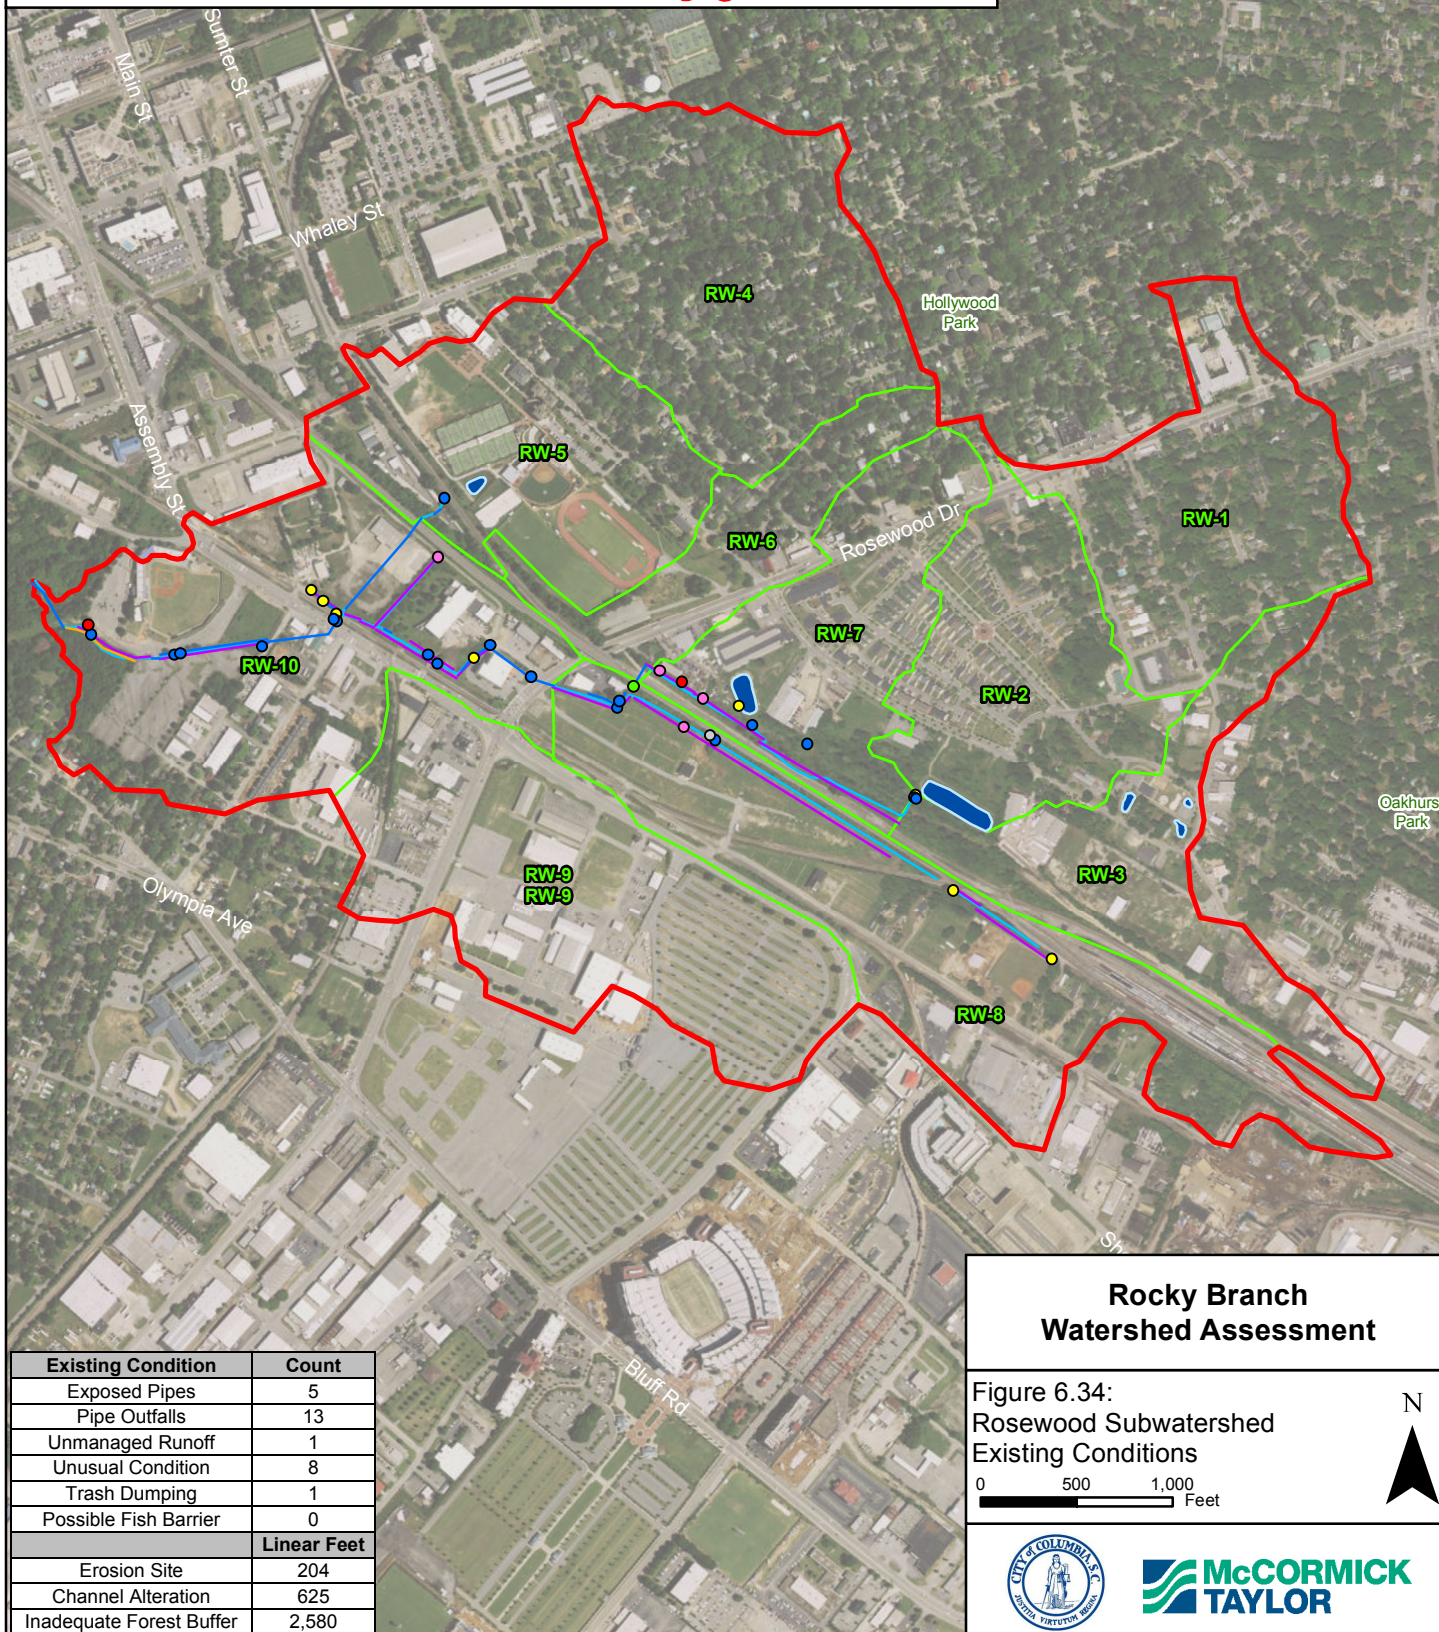
Figure 6.34:  
Rosewood Subwatershed  
Existing Conditions

**Figure 6.34** highlights existing conditions that were either captured during the stream cruising effort or developed using GIS data.

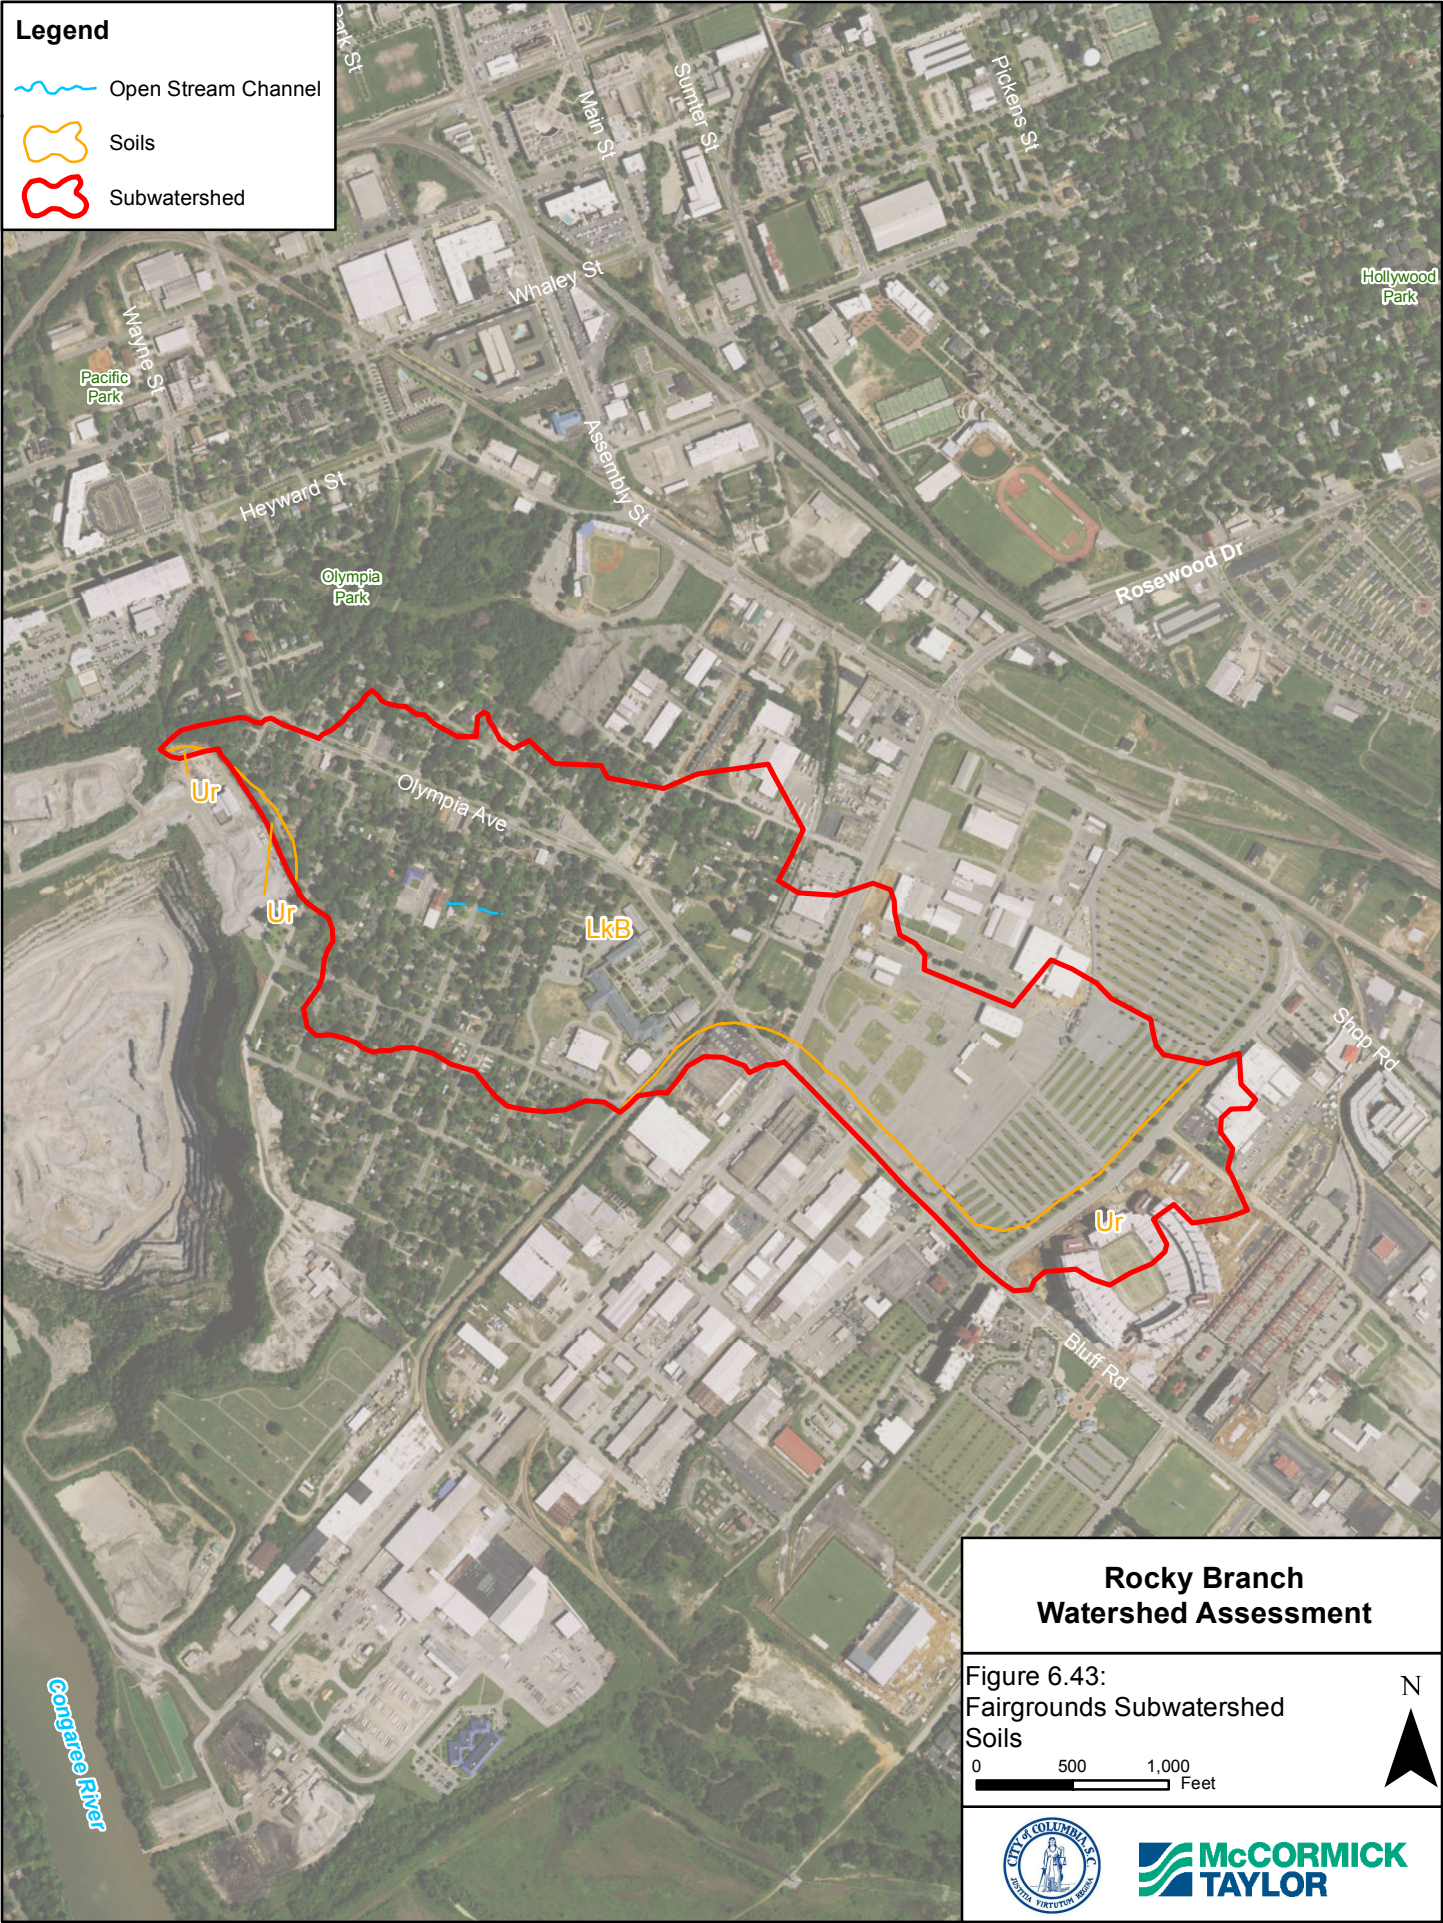
The habitat in this stream segment is poor overall. The main habitat impairments observed include embeddedness, lack of riparian buffer, little bed feature diversity, and poor epifaunal substrate/available cover. Approximately 70% of the open channel segment lacks a 35-foot wide or greater riparian buffer, with herbaceous vegetation typically mowed, including portions of the stream banks. Some small shrubs and vines are present along the right bank toward upstream end of the reach.

Four outfalls were identified within the FG subwatershed, all of which were considered to be in minor or moderate condition.

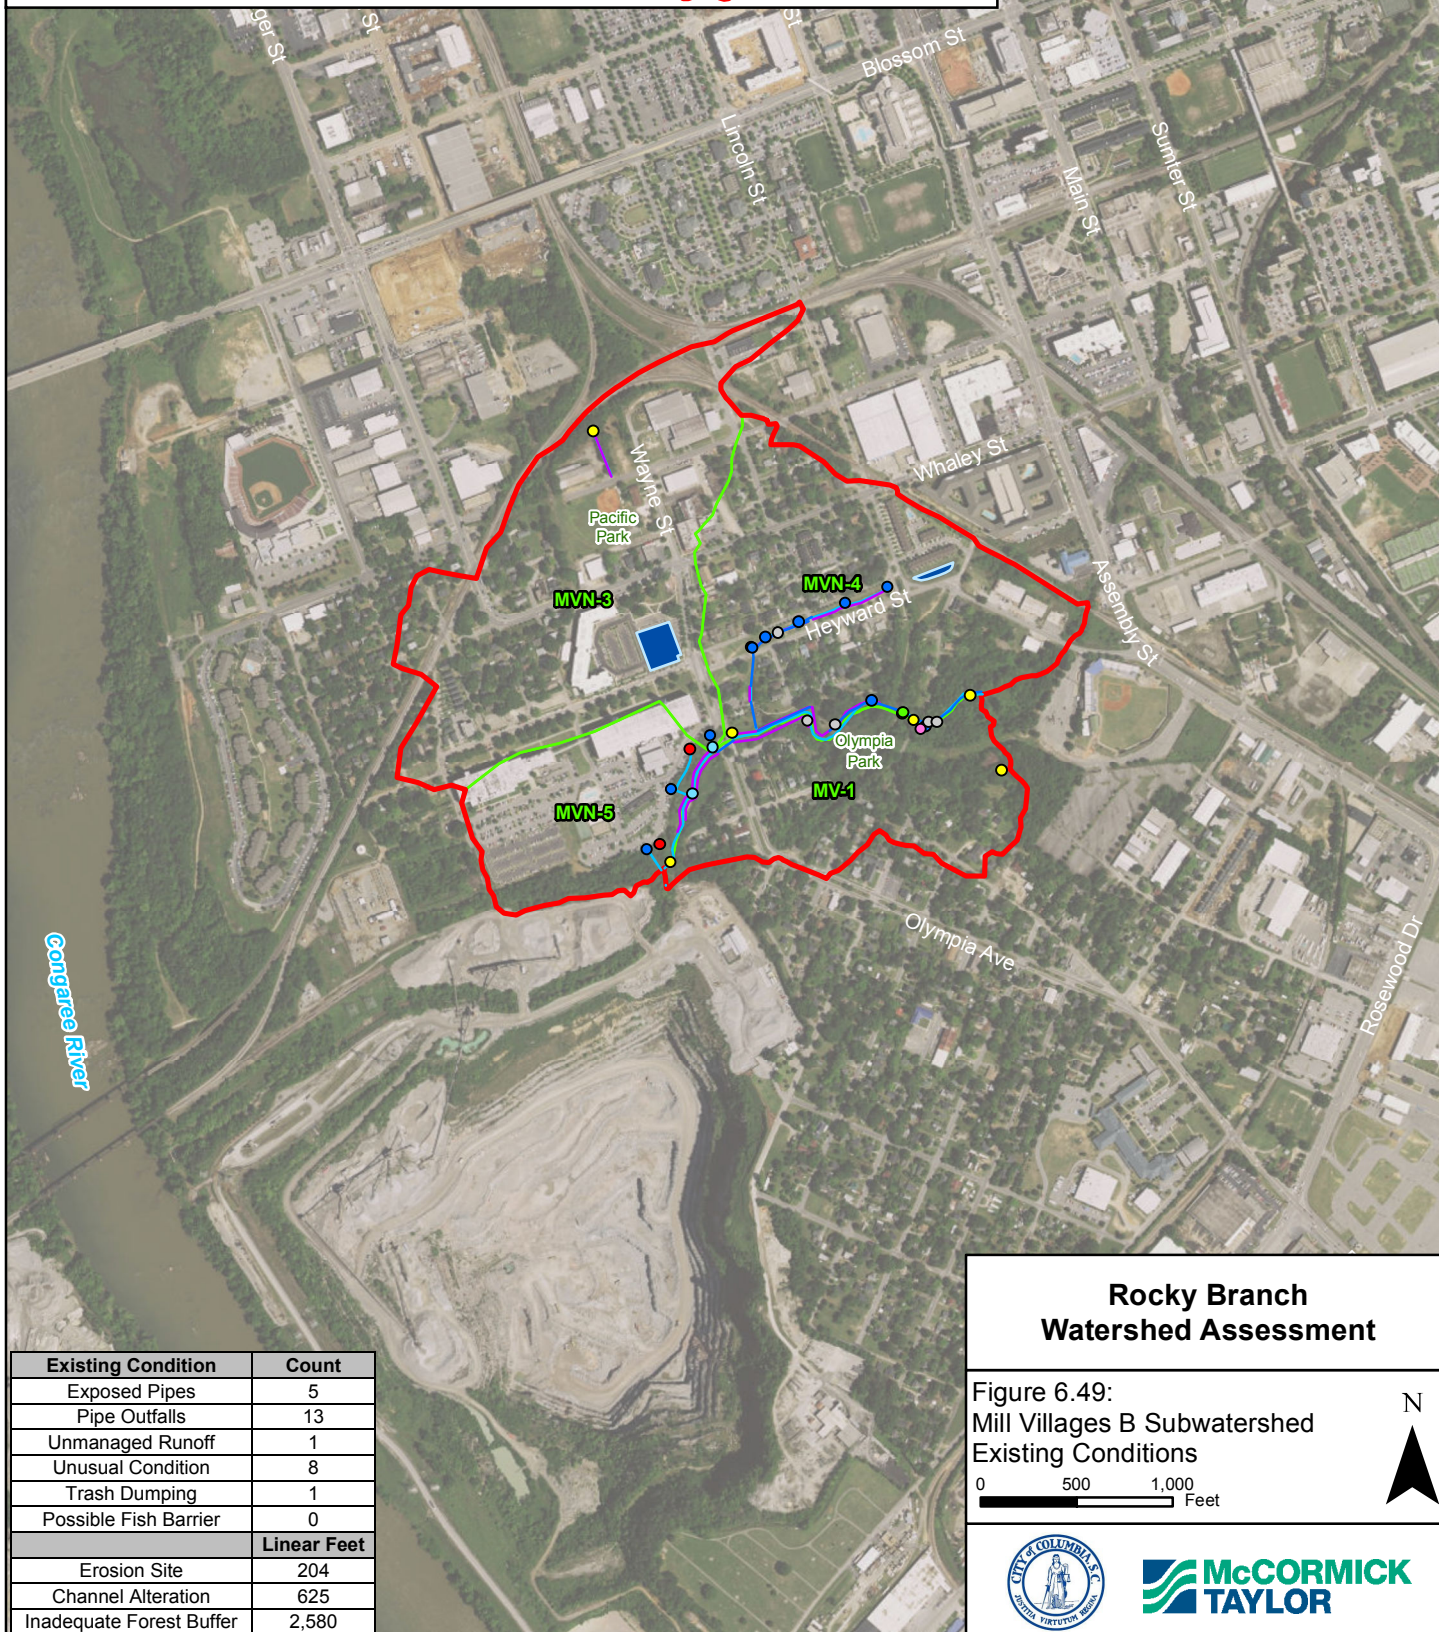
Figure 6.49:  
Mill Villages B Subwatershed  
Existing Conditions

Existing Condition	Count
Exposed Pipes	5
Pipe Outfalls	13
Unmanaged Runoff	1
Unusual Condition	8
Trash Dumping	1
Possible Fish Barrier	0
	Linear Feet
Erosion Site	204
Channel Alteration	625
Inadequate Forest Buffer	2,580

The MV-B subwatershed channel network begins at the confluence with a tributary on the left bank west of the Capital City Stadium, within a forested parcel. Large broken concrete slabs throughout the channel suggest past channelization and create small cascades within an otherwise sandy bed. The banks are approximately 5 to 7 feet tall and stabilized by the concrete and established vegetation. This segment ends at the culvert underneath Bluff Road.

Downstream of Bluff Road, the channel is open for 50 feet before flowing through a culvert underneath an abandoned railroad. This culvert was considered to be in very severe condition because of slope failure along the railroad embankment on the upstream side of the culvert. The segment downstream of the railroad is within Olympia Park. The right bank has been stabilized with riprap at the upstream end. There is a utility right of way with power lines that cross the stream 250 feet downstream of the abandoned railroad culvert. The bed consists of large deposits of sand, exposed bedrock outcroppings, and some riprap.

The stream is then conveyed through a road culvert at Olympia Avenue; the culvert was considered to be in very severe condition because of damage to the upstream headwall with the brick facade missing on the left side. There is a large scour hole immediately downstream of the Olympia Avenue culvert. The downstream channel segment has large sand and gravel deposits and an exposed sanitary line spanning over the mainstem supported by concrete and brick piers within the active bed. The stream runs between a parking lot for the Granby Apartments on the right bank and a utility right of way on the left.

Ten outfalls were identified within the MV-B subwatershed during the field investigation. One outfall was considered to be in severe condition, located northwest of the Olympia Avenue, Alabama Street intersection. The channel is incised and instability at the head of the channel, and water quality discharging into the mainstem is poor. The outfall is overgrown with roots, vines, and other vegetation, and overland flow enters the head of the channel from multiple directions, including unmanaged runoff from Olympia Avenue.
