# ROCKY BRANCH WATERSHED ASSESSMENT

MAY 20, 2016

CITY OF COLUMBIA  
UTILITY AND ENGINEERING DEPARTMENT  
1136 WASHINGTON STREET, 7TH FLOOR  
COLUMBIA, SOUTH CAROLINA 29201

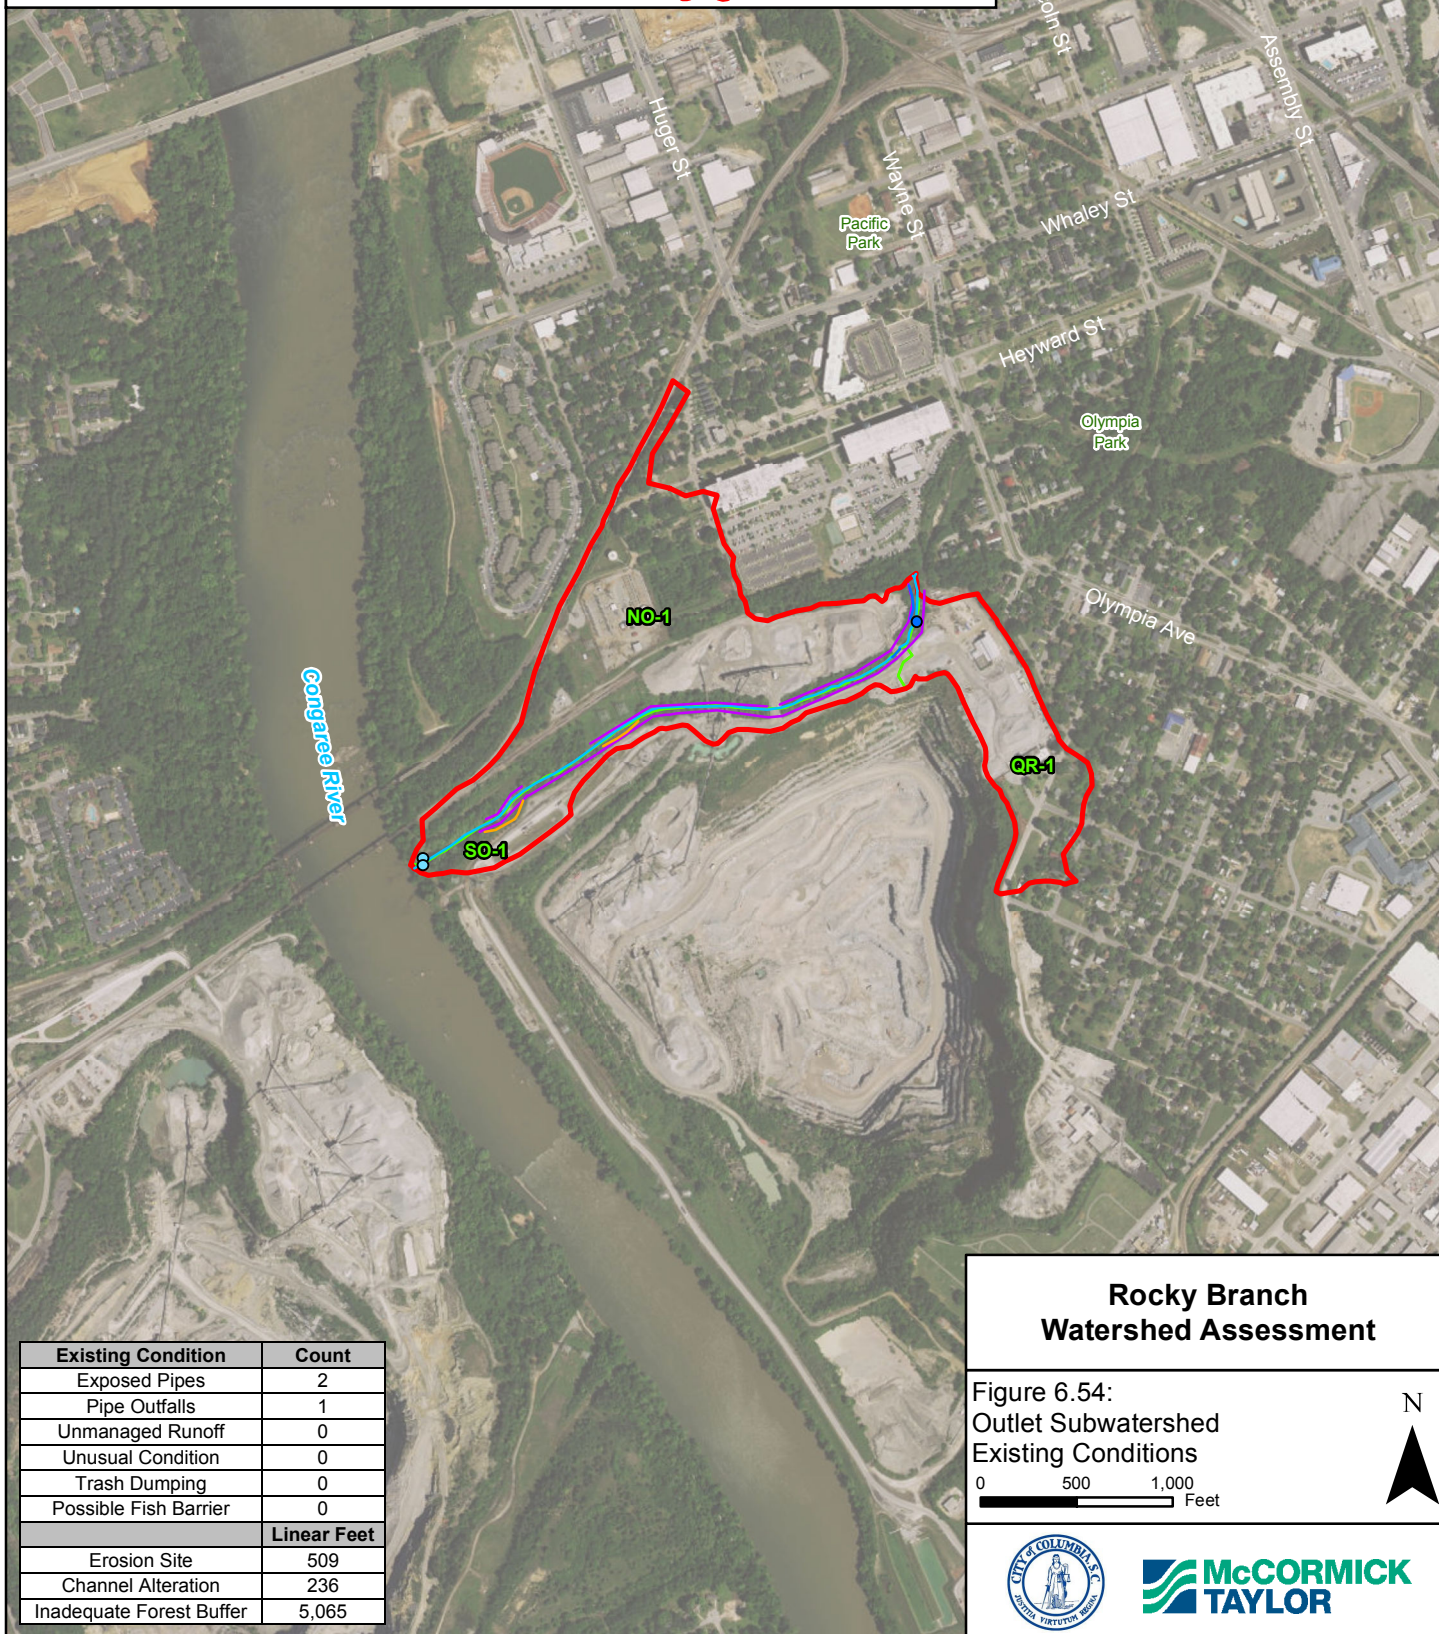
Stream habitat quality throughout this segment is mostly fair, with decreasing impairment towards the upstream limit and poorer conditions observed near the confluence with the Congaree River. Embeddedness and heavy sediment deposition are common issues within the stream bed, while lack of vegetative protection on the banks and little to no riparian buffer is impacting overall bank stability. The backwater conditions at the mouth of Rocky Branch have created a deep pool with a thick layer of deposited sand and silt within the bed, greatly reducing the quality of the habitat in this segment.

The narrow stream valley and proximity to the mine and railroad has limited space available for a riparian buffer, though there are small pine trees growing on the steep banks in some locations. Approximately 80% of the stream banks were observed to be lacking a 35-foot or greater riparian buffer width. Some portions of the right bank at the downstream limits of the reach and on the left bank at the mouth of Rocky Branch had an adequate vegetated width.

Only one outfall was identified during a field review in the OT subwatershed. This outfall was observed to be in moderate condition.

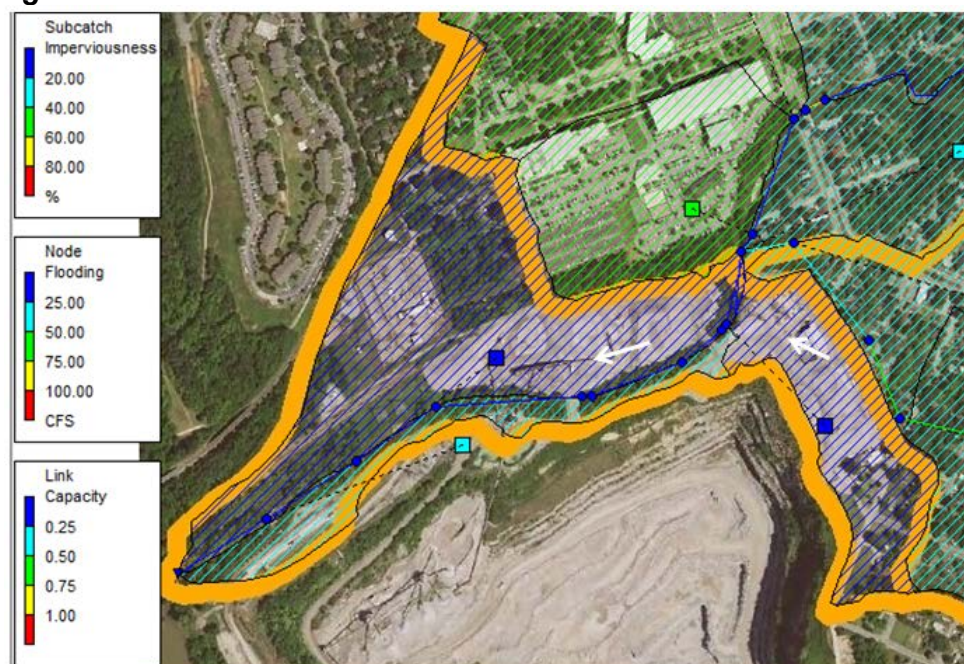
**Figure 6.55 OT SWMM Model**

The OT subwatershed was modeled as three subcatchments in SWMM. The flows from these subcatchments are linked directly to the Rocky Branch mainstem. Most of the OT subwatershed is within the Vulcan Materials mine.

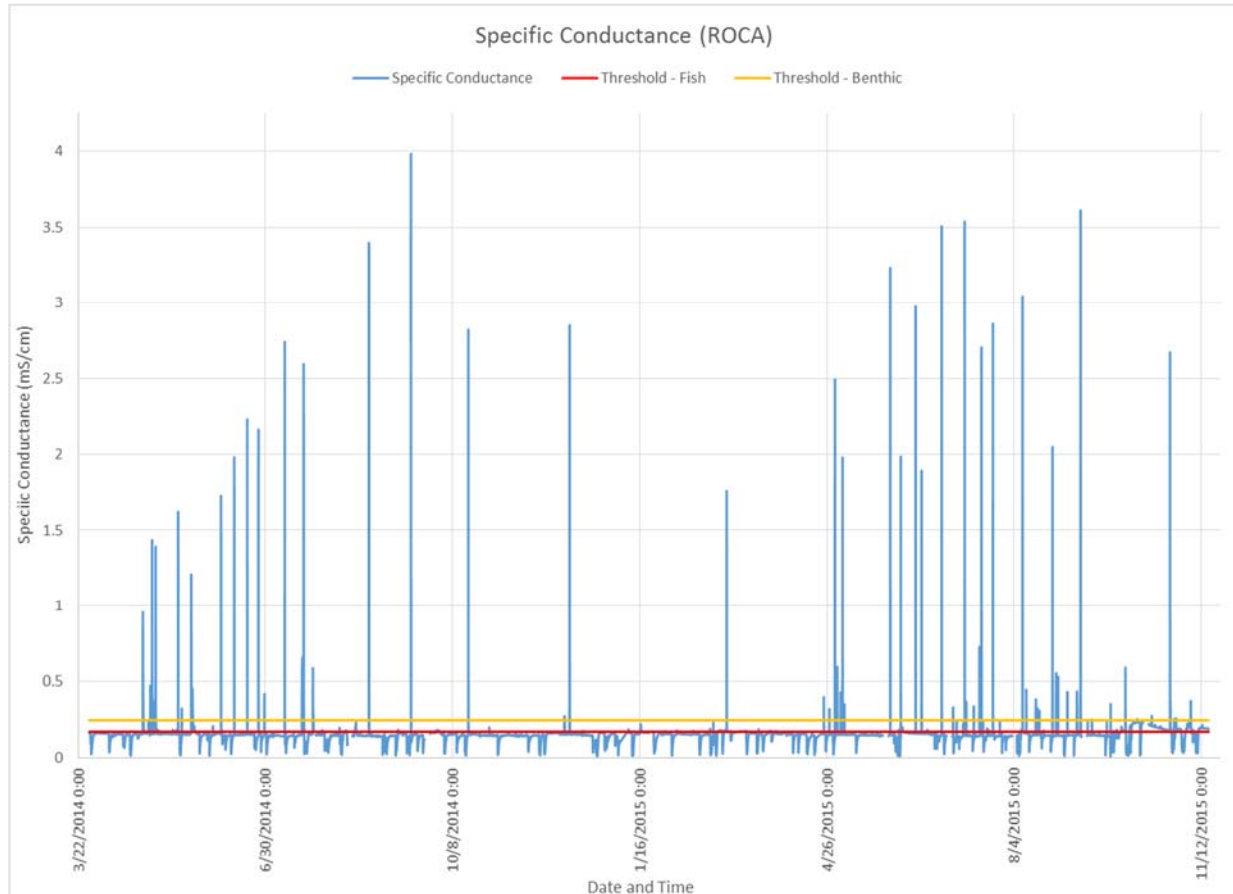
South Carolina does not have water quality criteria for specific conductance, which is a measure of dissolved inorganic ions such as chloride, nitrate, sulfate and phosphate anions and sodium, magnesium, calcium, iron, and aluminum cations. Morgan et al., 2007, found biological assemblage impairment thresholds for biological impairment of 0.247 mS/cm for benthic macroinvertebrates and 0.171 mS/cm for fish in urban streams in Maryland. Rocky Branch is an urban stream so the impairment thresholds from Maryland data may be applicable. When compared against these values, the possible specific conductance impairment thresholds were exceeded in ROCA for benthic macroinvertebrate assemblage 1.26% of the time (666 records out of 52,819 total records), and for fish assemblage 12.84% of the time (6,780 records out of 52,819 total records).

Site ROCA had higher maximum observed specific conductance values than ROCB, but a much lower percentage of values above the possible biological assemblage impairment thresholds. At ROCA, almost

without exception, the highest specific conductivity events were observed with concomitant spikes in turbidity.

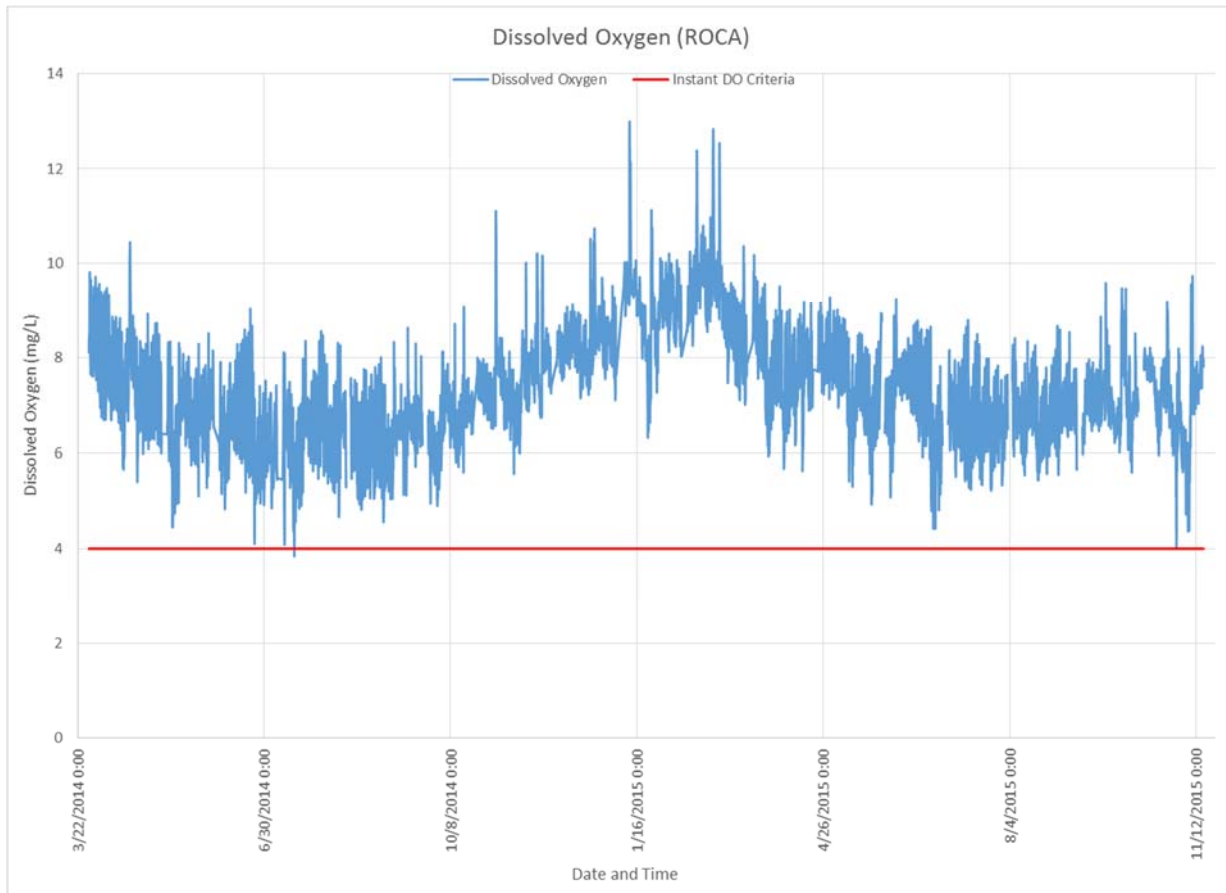
### *Dissolved Oxygen*

Water quality sonde data from site ROCA show that the instantaneous water quality standard for dissolved oxygen of 4.0 mg/L was violated 0.01% of the time (4 out of 52,929 records) over the period of record. Over the same period of time, the water quality standard for daily average dissolved oxygen of 5.0 mg/L was violated 0.00% of the time (0 out of 555 days). The instantaneous criteria violations happened over a 45-minute period on July 16<sup>th</sup>, 2014 from 05:15 to 06:00. July 16<sup>th</sup>, 2014 also had the lowest observed daily average dissolved oxygen concentration of 5.28 mg/L.

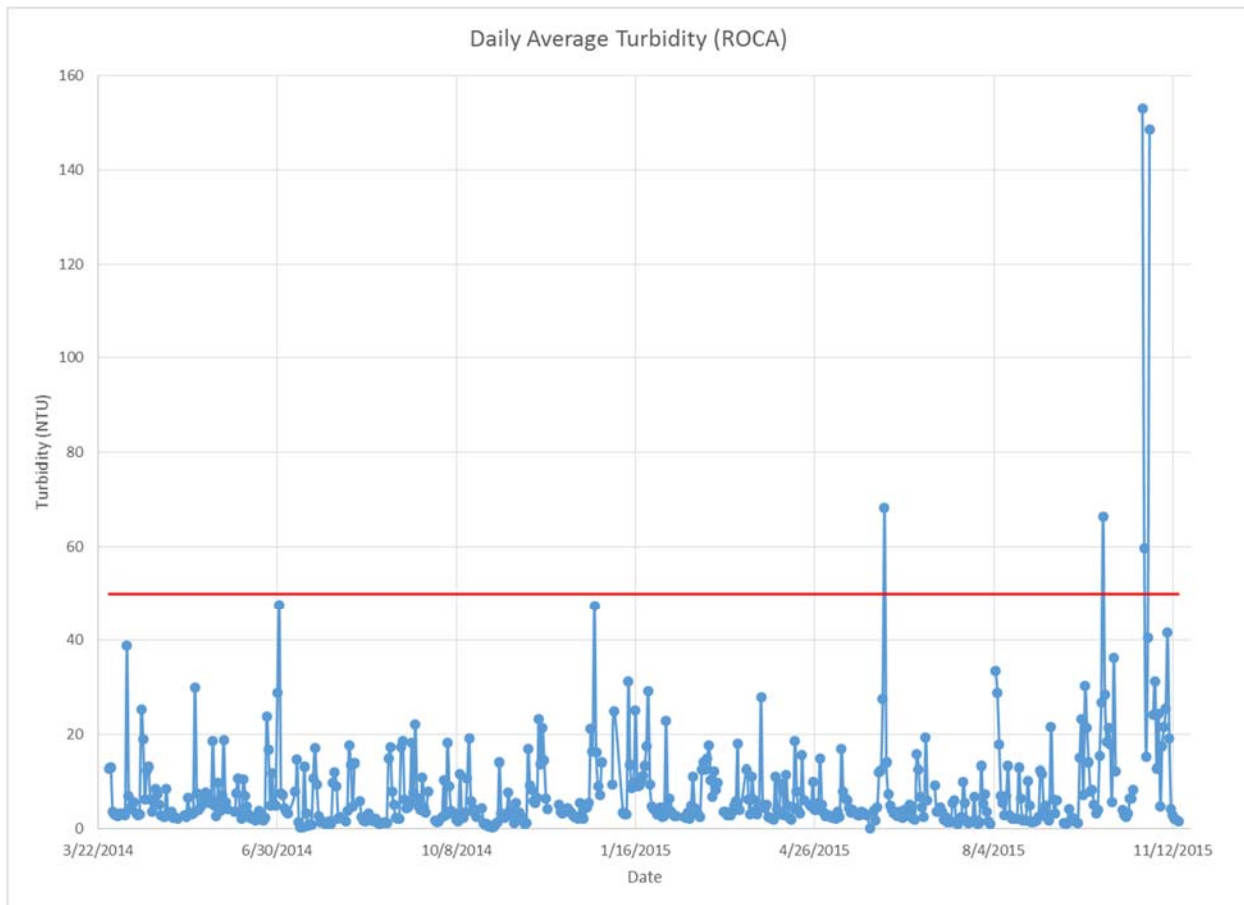
### *Turbidity*

Results of turbidity data from the water quality sonde at ROCA show that the turbidity water quality standard of 50.0 NTU was exceeded 1.27% of the time (644 records out of a total 50,609 records).

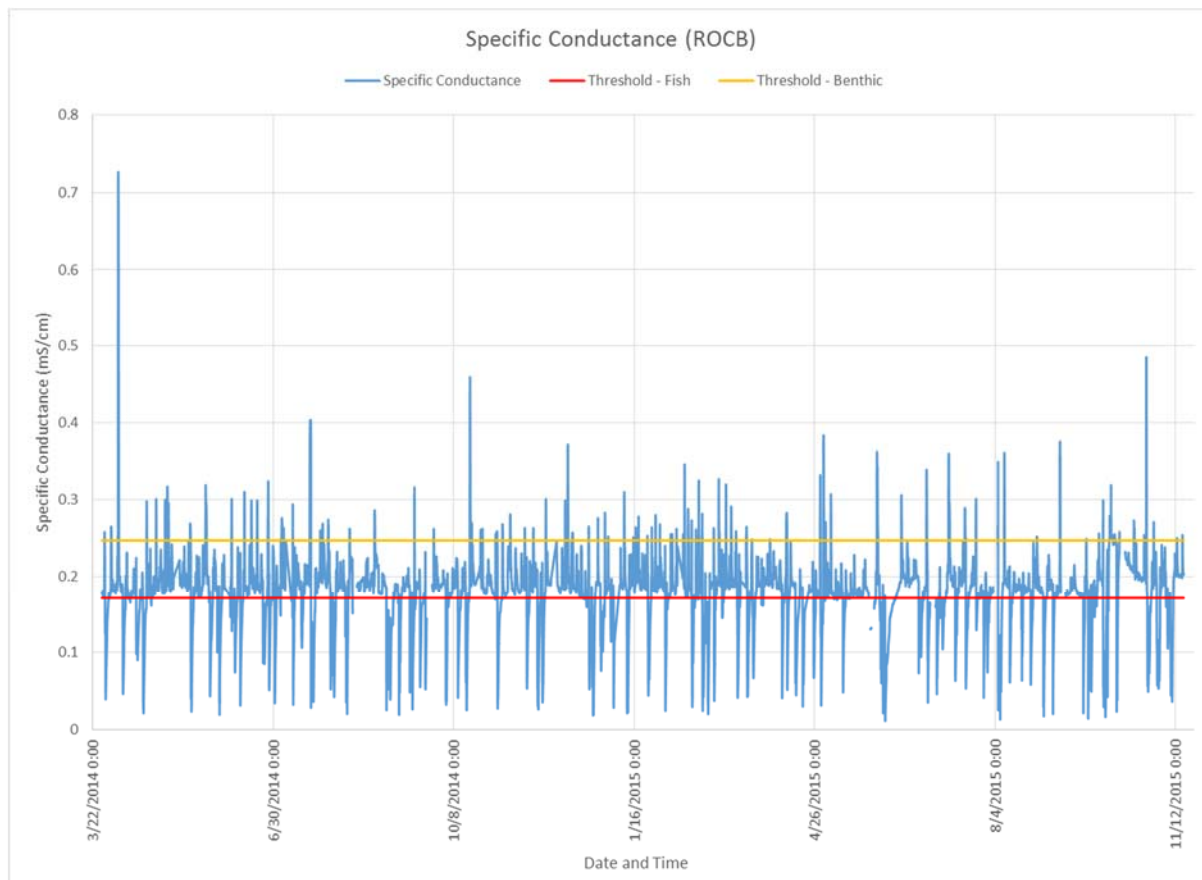
South Carolina does not have water quality criteria for specific conductance, which is a measure of dissolved inorganic ions such as chloride, nitrate, sulfate and phosphate anions and sodium, magnesium, calcium, iron, and aluminum cations. Morgan et al., 2007, found biological assemblage impairment thresholds of for biological impairment of 0.247 mS/cm for benthic macroinvertebrates and 0.171 mS/cm for fish in urban streams in Maryland. Rocky Branch is an urban stream so the impairment thresholds from Maryland data may be applicable. When compared against these values, the possible specific conductance impairment thresholds were exceeded in ROCB for benthic macroinvertebrate assemblage

4.35% of the time (2,318 records out of 53,246 total records), and for fish assemblage 74.99% of the time (39,931 records out of 53,246 total records).

Site ROCB had lower maximum observed specific conductance values than ROCA, but had a higher percentage of values above the possible biological assemblage impairment thresholds. These data suggest that site ROCB has a chronic specific conductivity condition that may limit the ecological health of this portion of Rocky Branch.

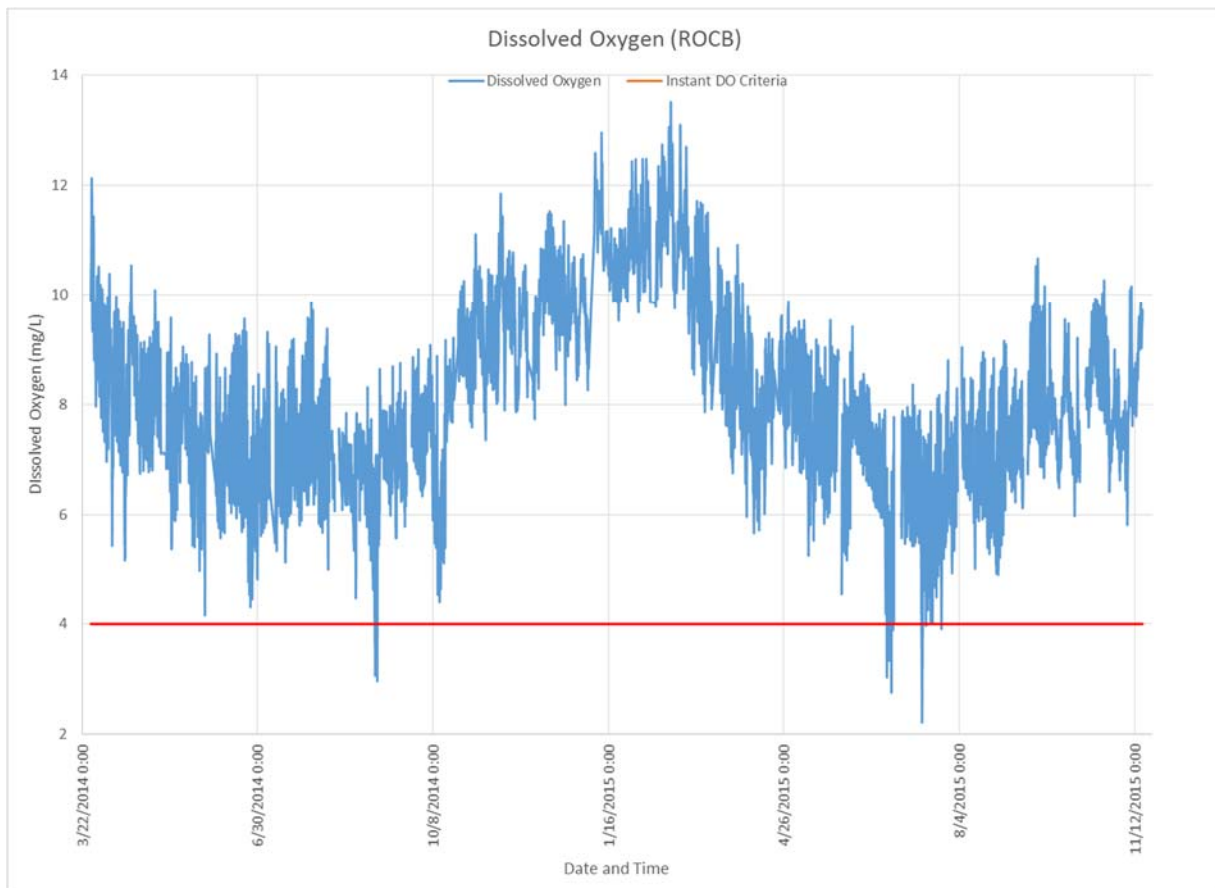
### *Dissolved Oxygen*

Water quality sonde data from site ROCB show that the instantaneous water quality standard for dissolved oxygen of 4.0 mg/L was violated 0.26% of the time (138 out of 53,138 records) over the period of record. Over the same period of time, the water quality standard for daily average dissolved oxygen of 5.0 mg/L was violated 0.89% of the time (5 out of 559 days). The daily criteria violations happened over a 4-day period from June 23<sup>rd</sup> through June 26<sup>th</sup>, 2015, and during July 13<sup>th</sup>, 2015.

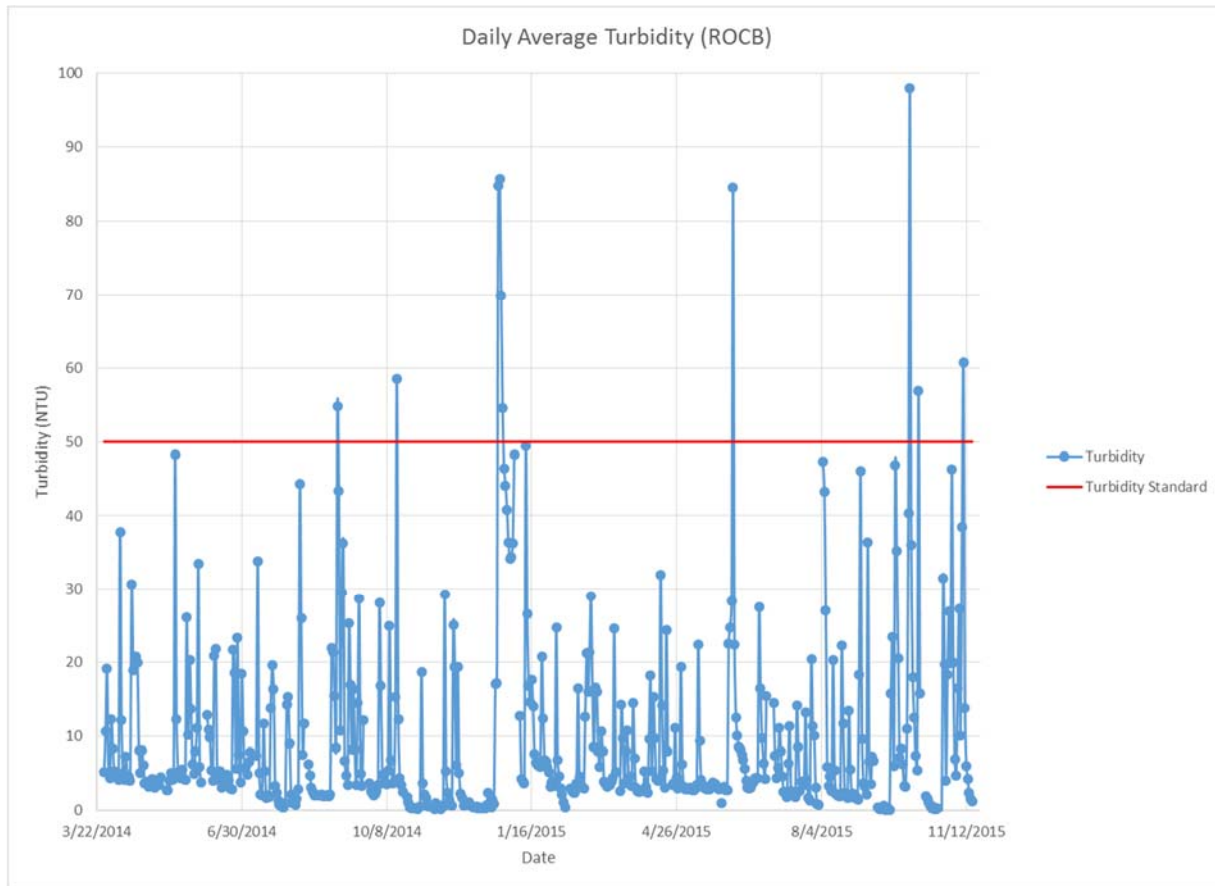
### *Turbidity*

Water quality sonde data from site ROCB show that water quality standard for turbidity of 50 NTU was violated 3.58% of the time (1894 out of 52,836 records) over the period of record.
